**Minerals Regulatory Program
Inspection Report**

Mine Name: Velvet	Inspection Date: 12/10/2025
Permit Number: M0370040	Lead Inspector: Tabitha Hatch
Mine Status: Active	Secondary Inspector(s): Steve Demczak, Bailee Jones
Operator: Anfield Resources Holding Corp	Prior Inspection:
Attendee(s): Carrie Williams	Permit Fees: Paid
Weather: Sunny	Bond Amount: \$ 539,000
Reviewed By:	Bond Escalation: 10/26/2030
Conclusions and Recommendations: At the time of the inspection it was observed that the silt fences were not properly installed, the fencing around the portal was not anchored or locked, and there was trash in the waste pile. These issues will need to be addressed by the next inspection.

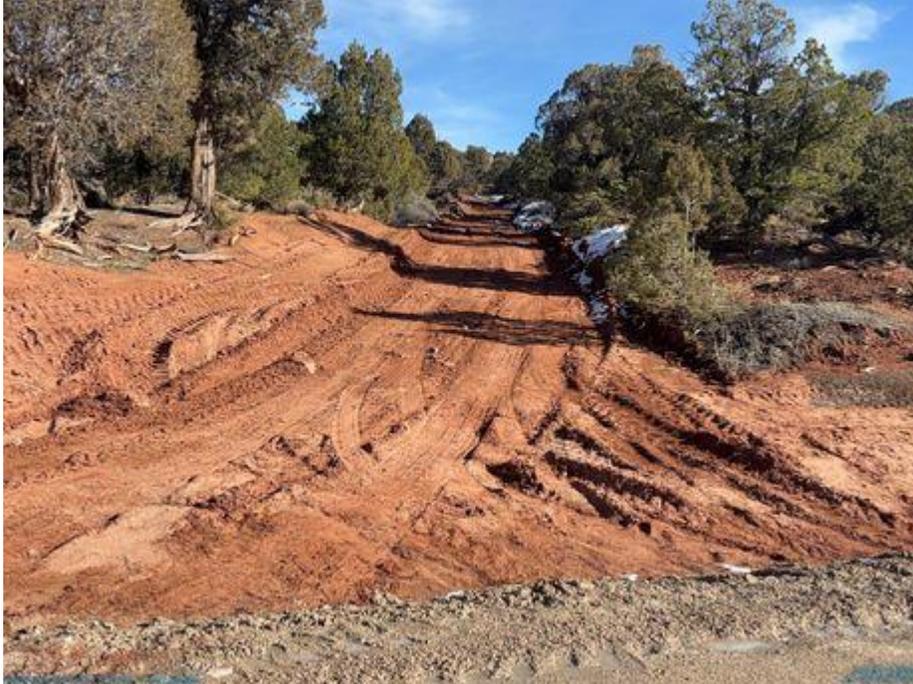
Latitude: 38.11775004555555, Longitude: -109.17077175
Road off to the left upon entrance. It is staked.

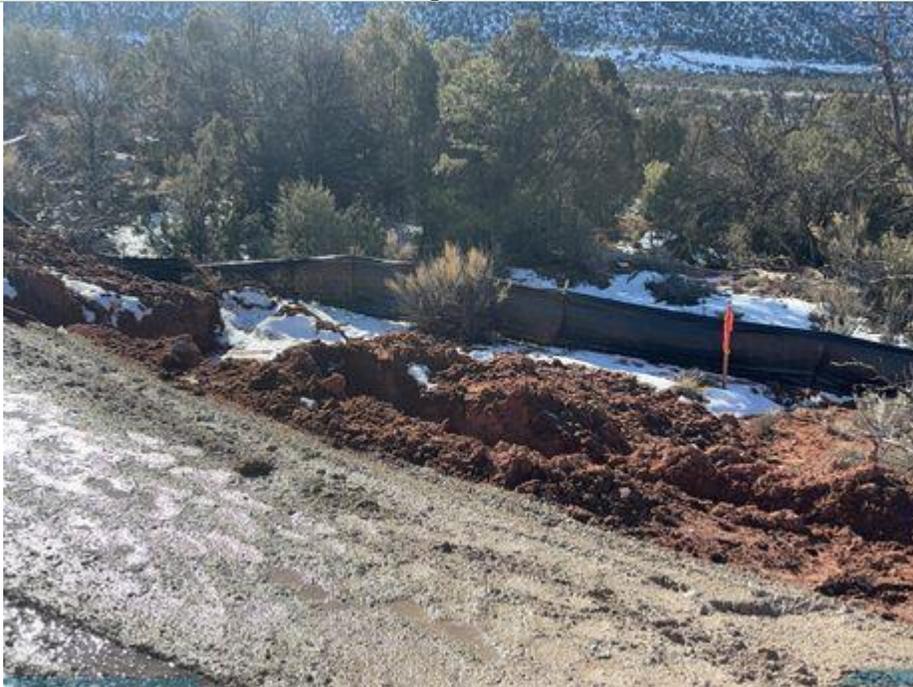
3. Protection of Drainages/Erosion Control	<input checked="" type="checkbox"/> Evaluated & Commented <input type="checkbox"/> Enforcement
Silt fence is not properly installed and will need to be fixed before the next inspection.

Latitude: 38.117668326111115, Longitude: -109.1706001388889
Silt fence must be redone. Gap underneath.

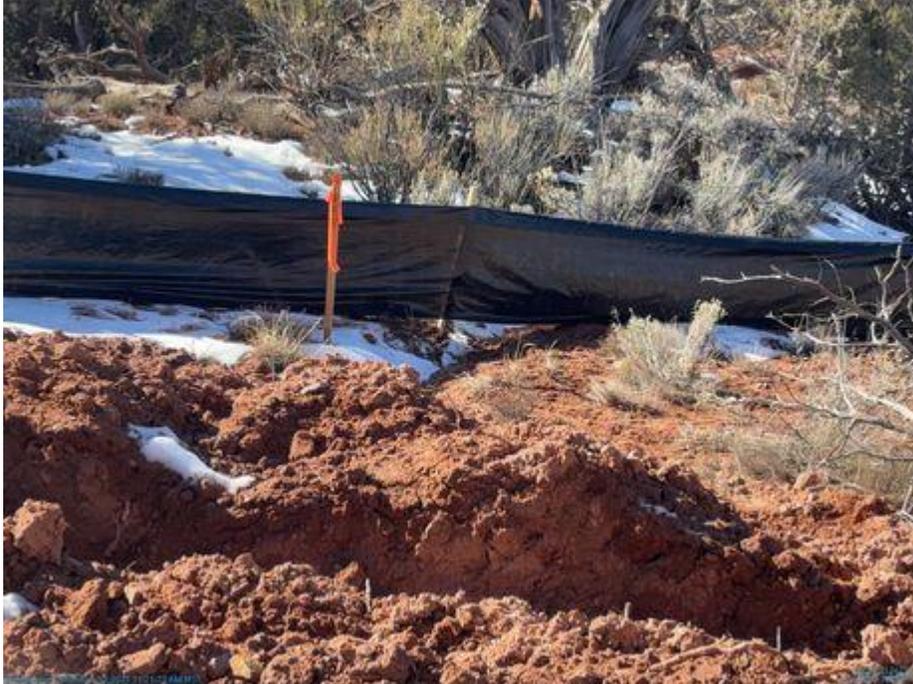
Latitude: 38.11762666111111, Longitude: -109.17059908888889
Gap closeup.

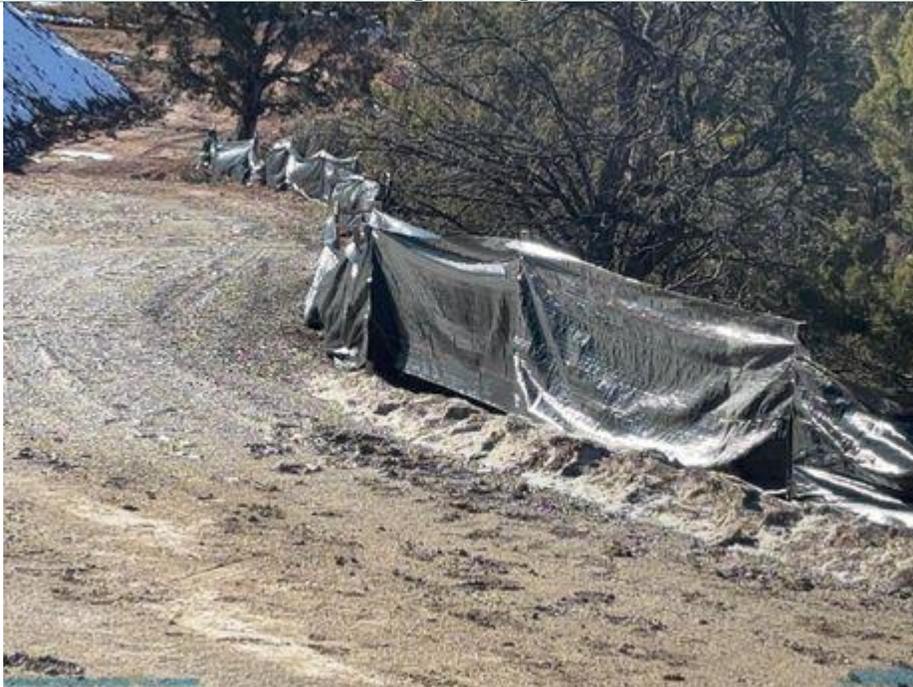
Latitude: 38.11752874444444, Longitude: -109.17047293611111
More gaps.

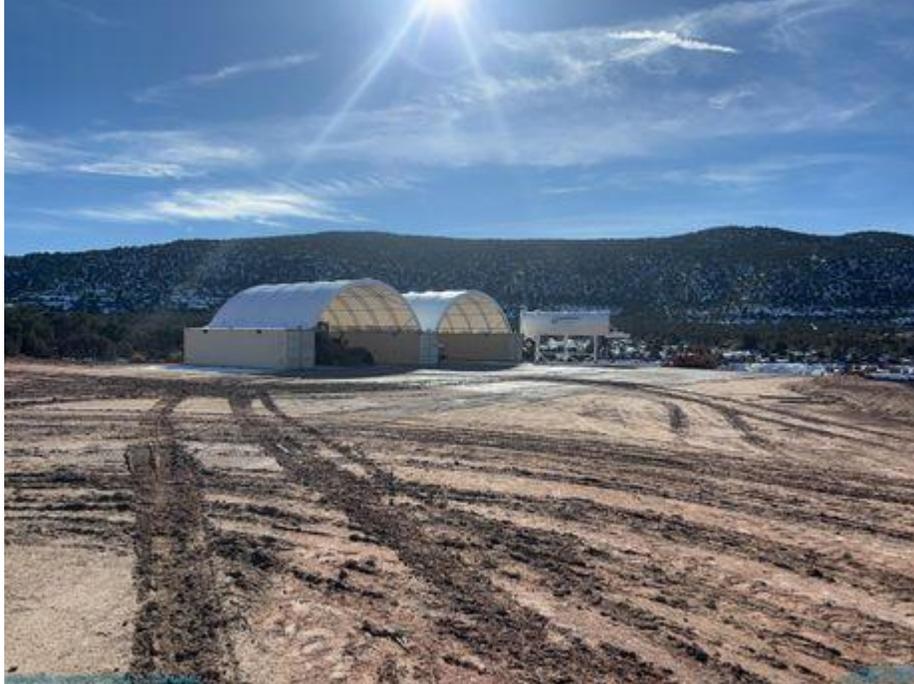
Latitude: 38.11718052055556, Longitude: -109.17017363055557
Truck area.

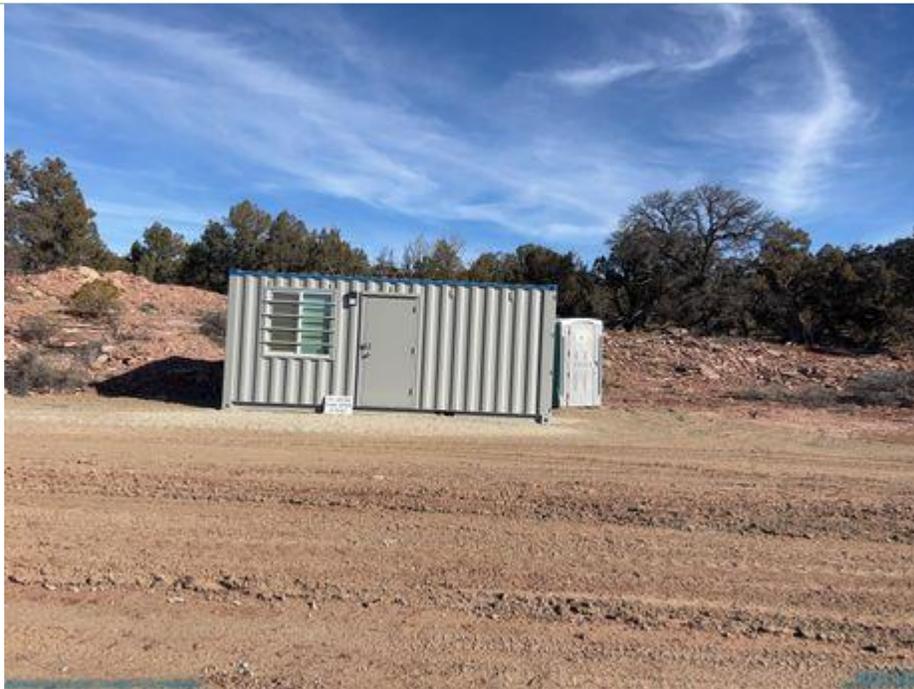
Latitude: 38.117175311666664, Longitude: -109.17017930555556
Check-in office.

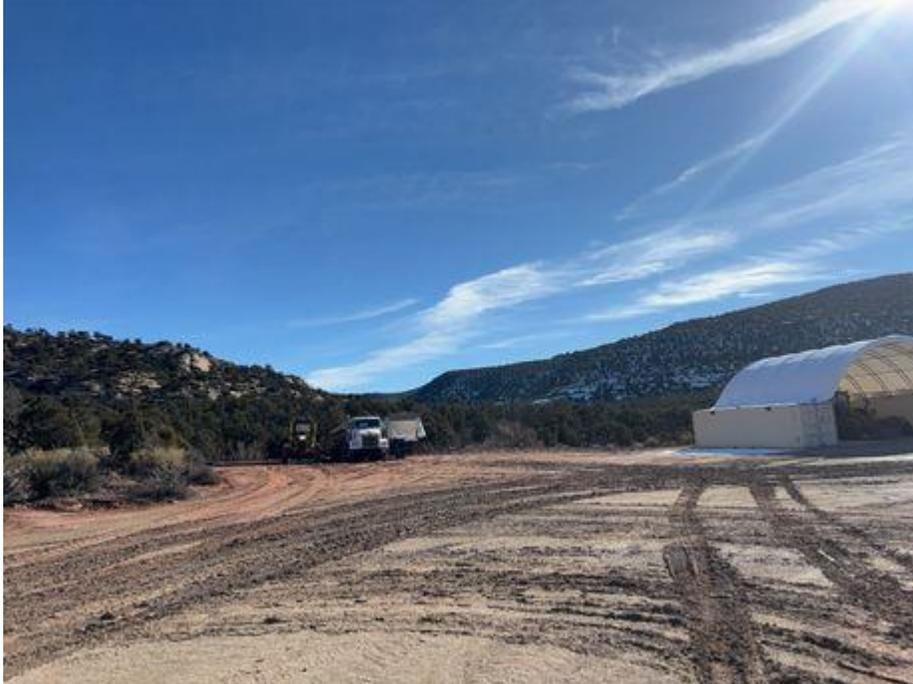
Latitude: 38.117176713333336, Longitude: -109.17017224722223
Onsite vehicles.

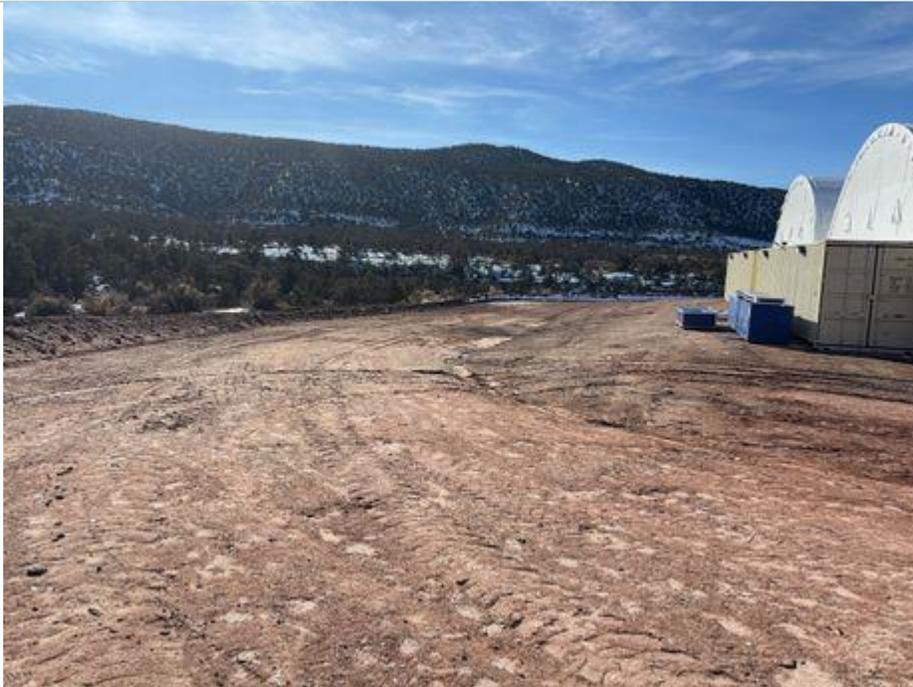
Latitude: 38.116981865833333, Longitude: -109.17002965555557
Berms look good.

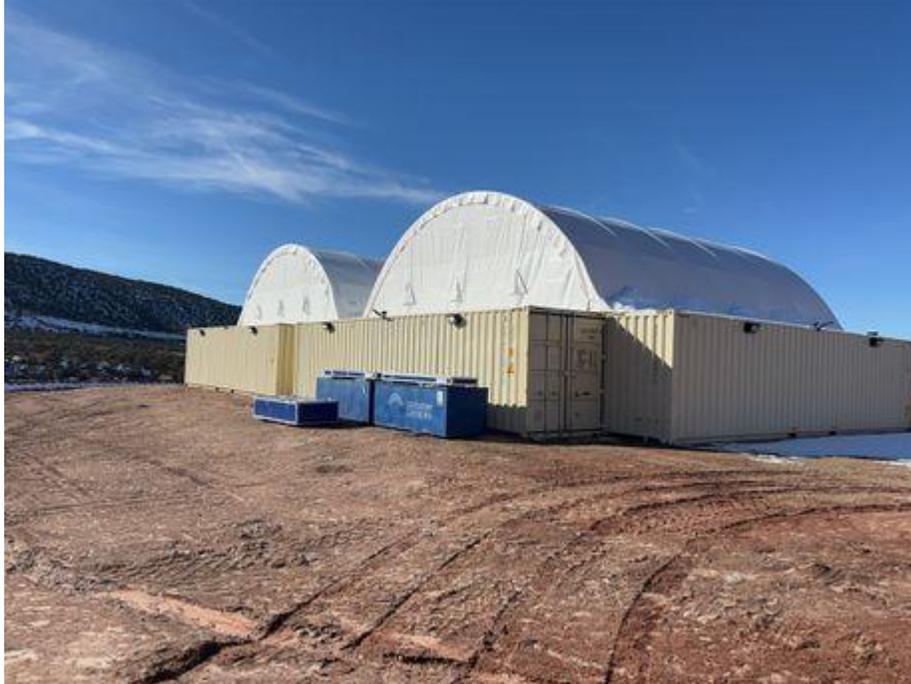
Latitude: 38.11675106777778, Longitude: -109.16964603611112
Backside of truck area.

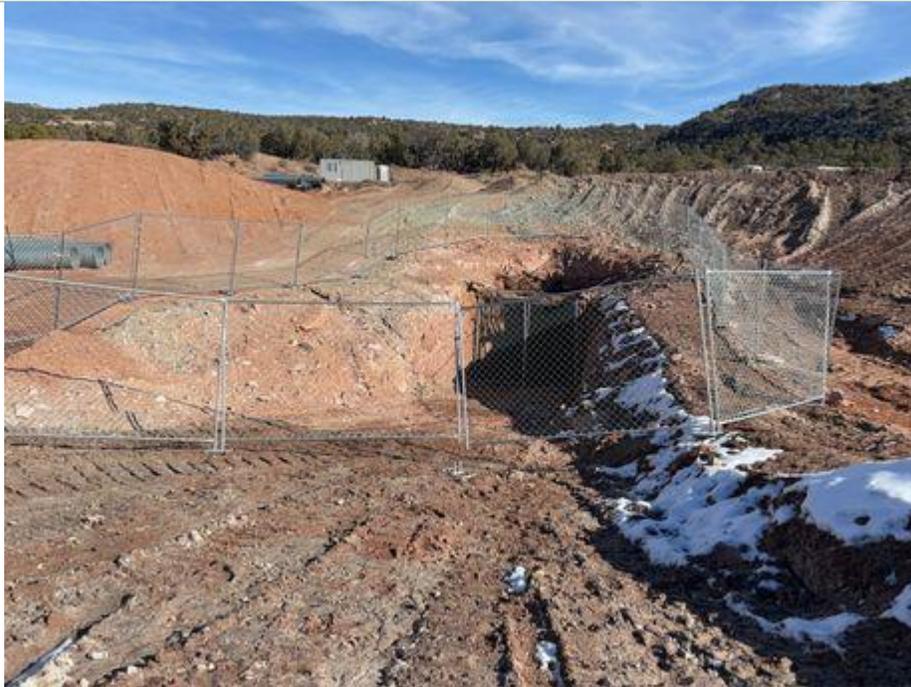
2. Public Safety (shafts, adits, trash, signs, highwalls)	<input checked="" type="checkbox"/> Evaluated & Commented <input type="checkbox"/> Enforcement
At the time of the inspection the portal was fenced off, but the fence was not anchored to the ground and had large gaps underneath. The inner gate blocking the portal entrance did not appear to have a lock on it. Not properly sealing the portal is a public safety concern and will need to be fixed by the date of the next inspection. Additionally, trash was observed in the waste pile and will need to be disposed of by the date of the next inspection.

Latitude: 38.11658213888889, Longitude: -109.17061233333334
Portal. Fence is not anchored and there is a large gap.

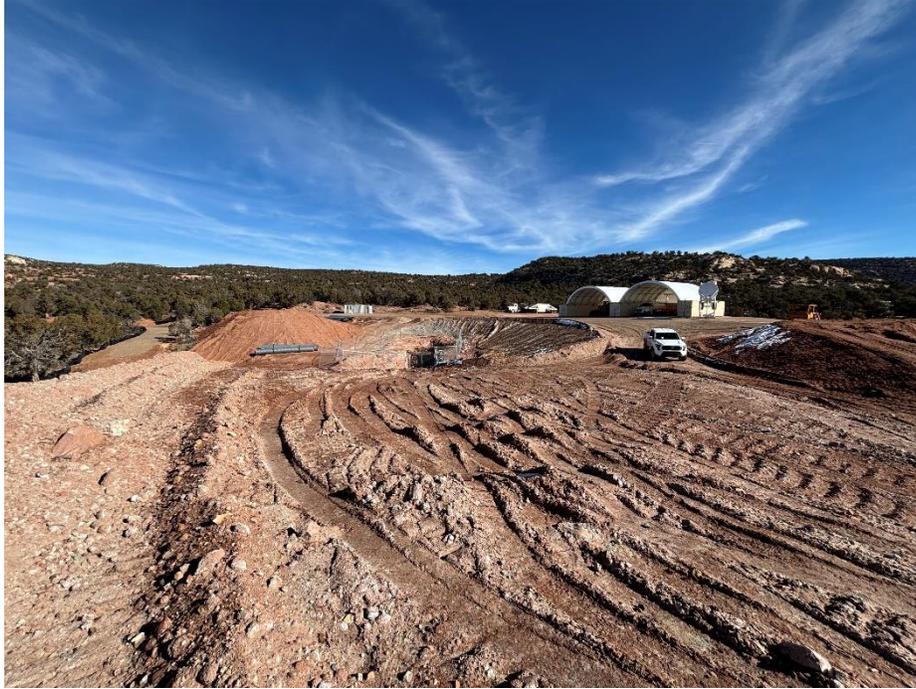
Latitude:, Longitude:
Site overview.

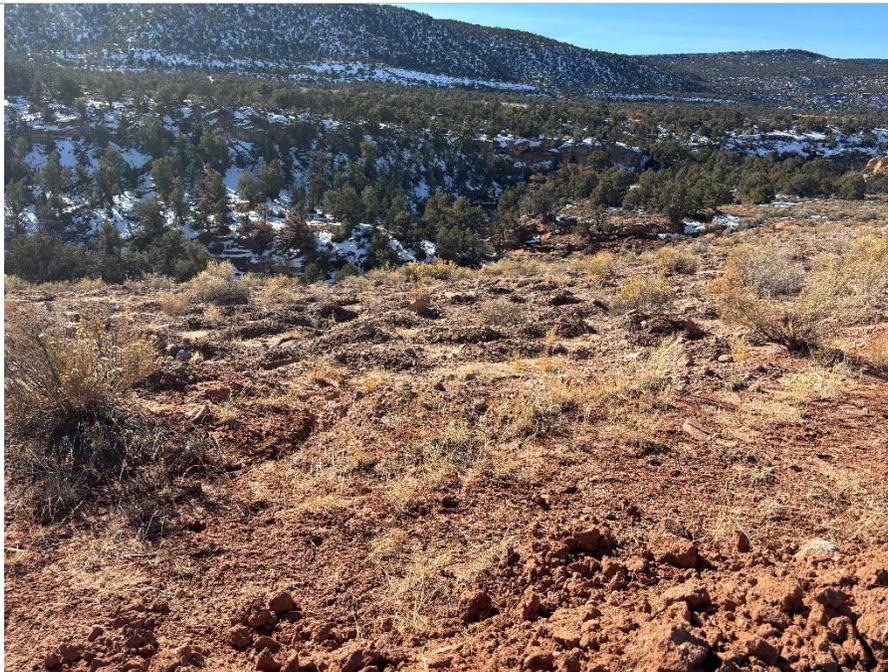
6. Reclamation	<input checked="" type="checkbox"/> Evaluated & Commented <input type="checkbox"/> Enforcement
Reclaimed area looks good.	
7. Backfilling/Grading (trenches, pits, roads, highwalls, shafts)	<input type="checkbox"/> Evaluated & Commented <input type="checkbox"/> Enforcement

Latitude: , Longitude:
Reclaimed area.

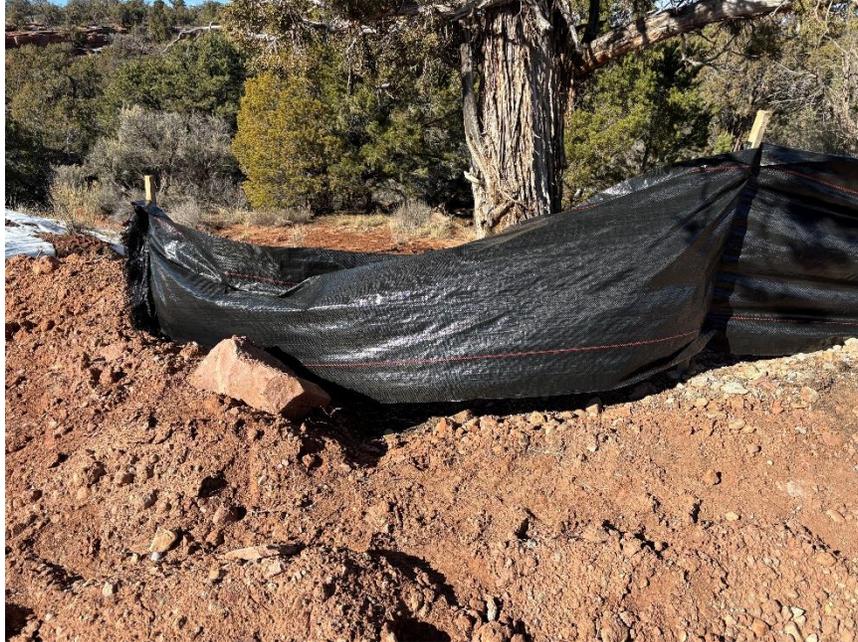
Latitude: , Longitude:
More silt fence gaps.

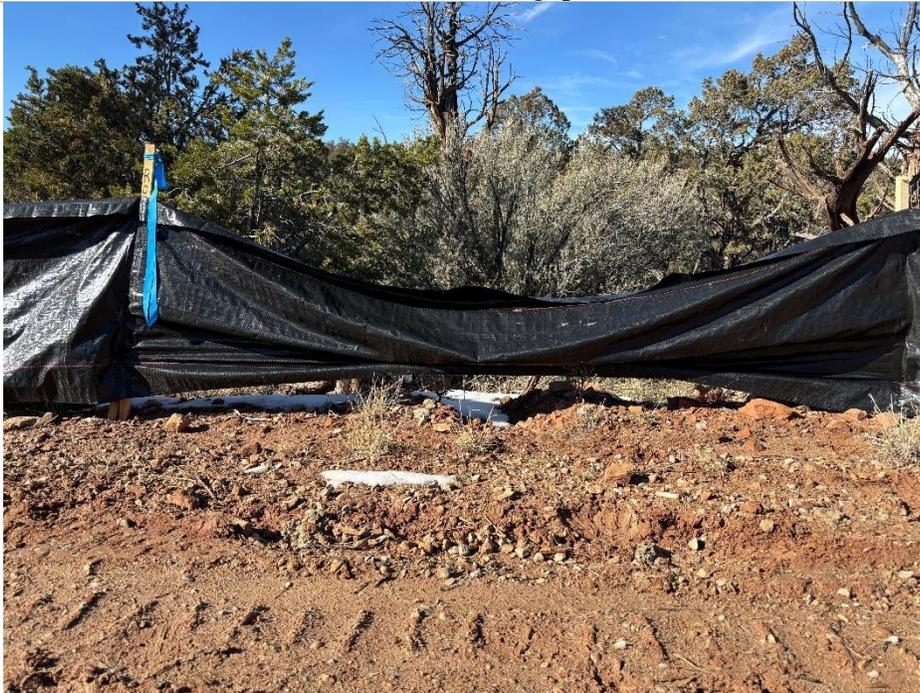
Latitude: , Longitude:
More gaps.

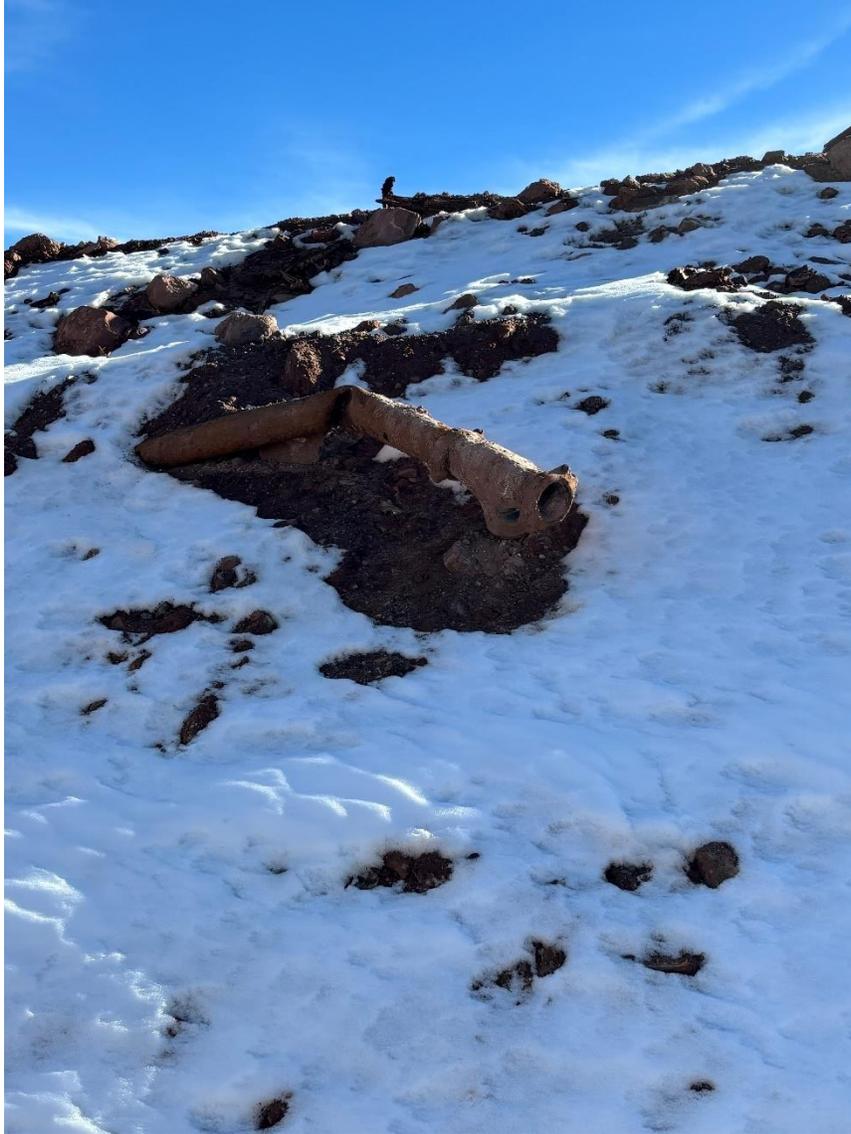
Latitude: , Longitude:
Trash in waste pile.

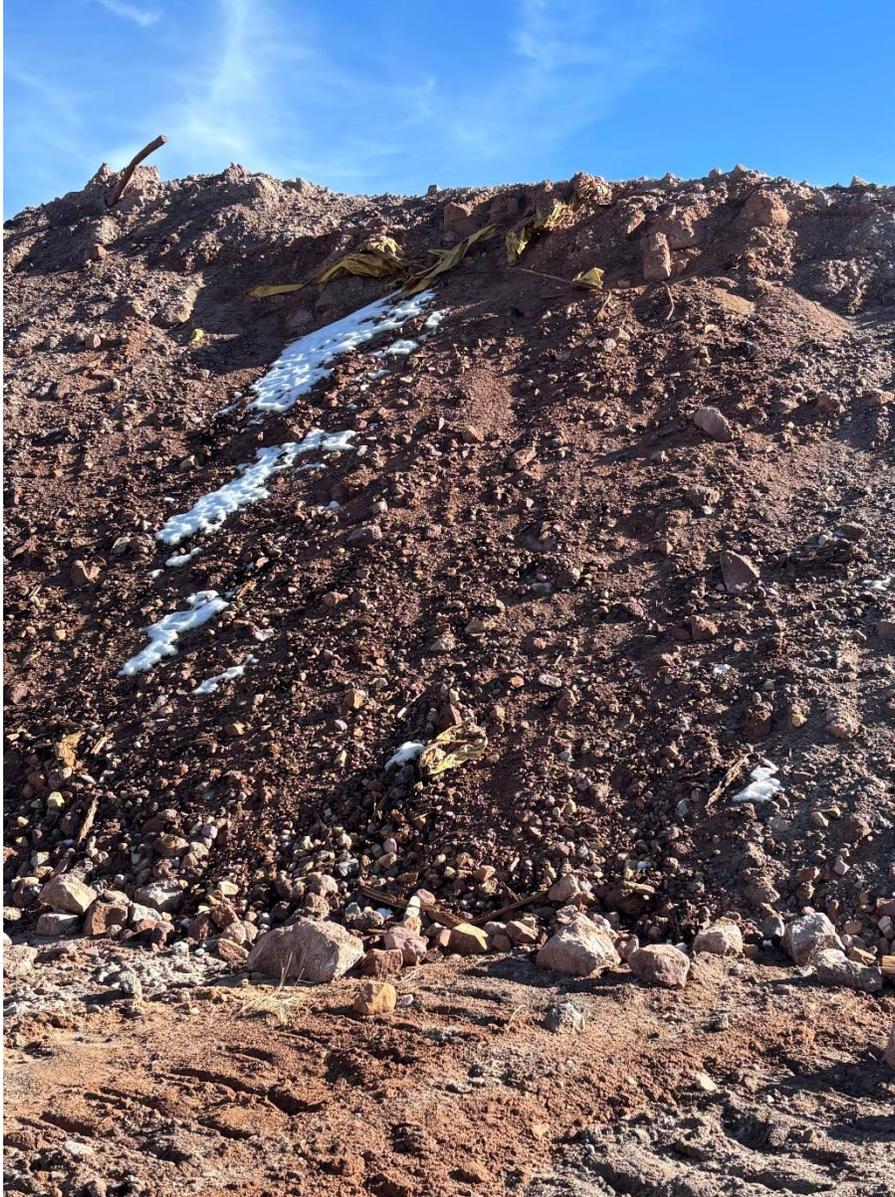
Latitude: , Longitude:
More trash.

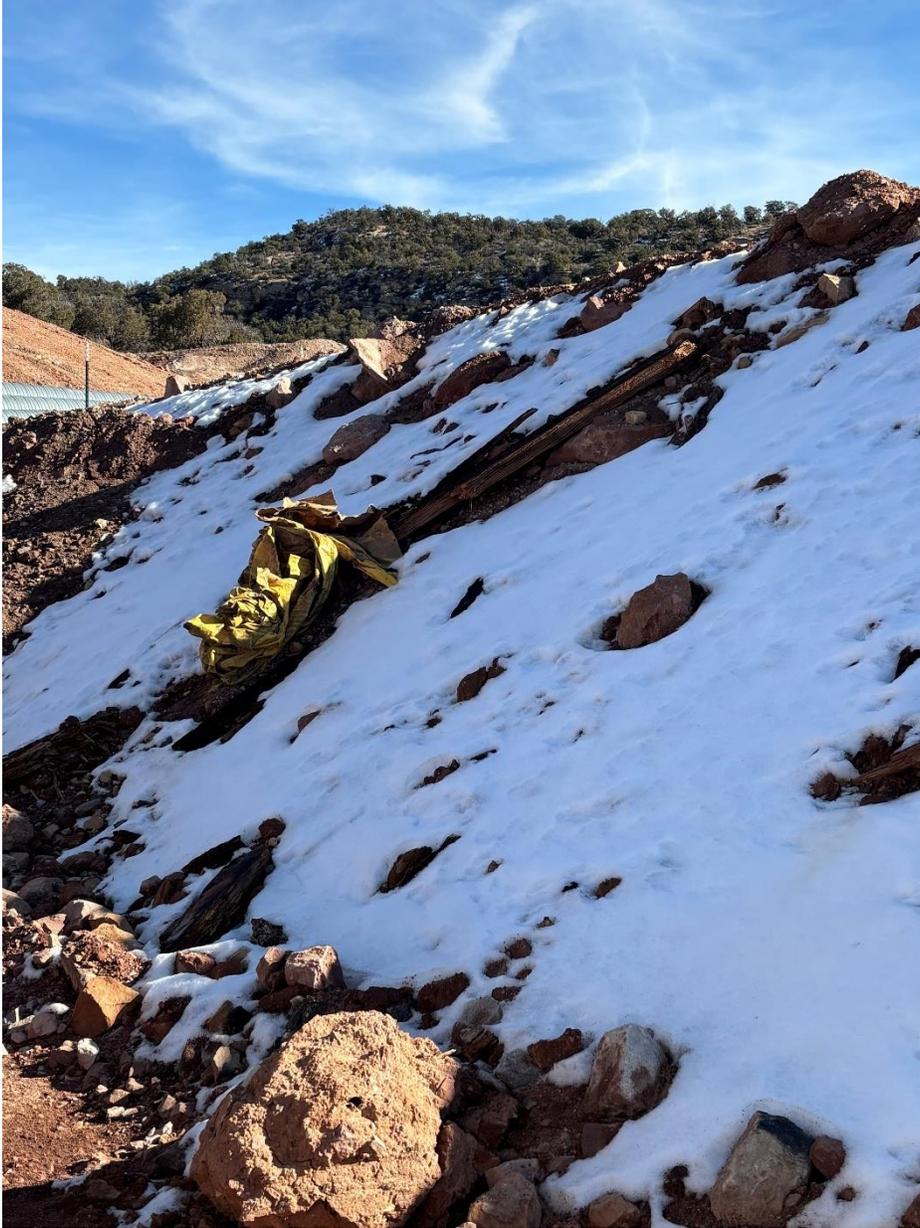
Latitude: , Longitude:
More trash.

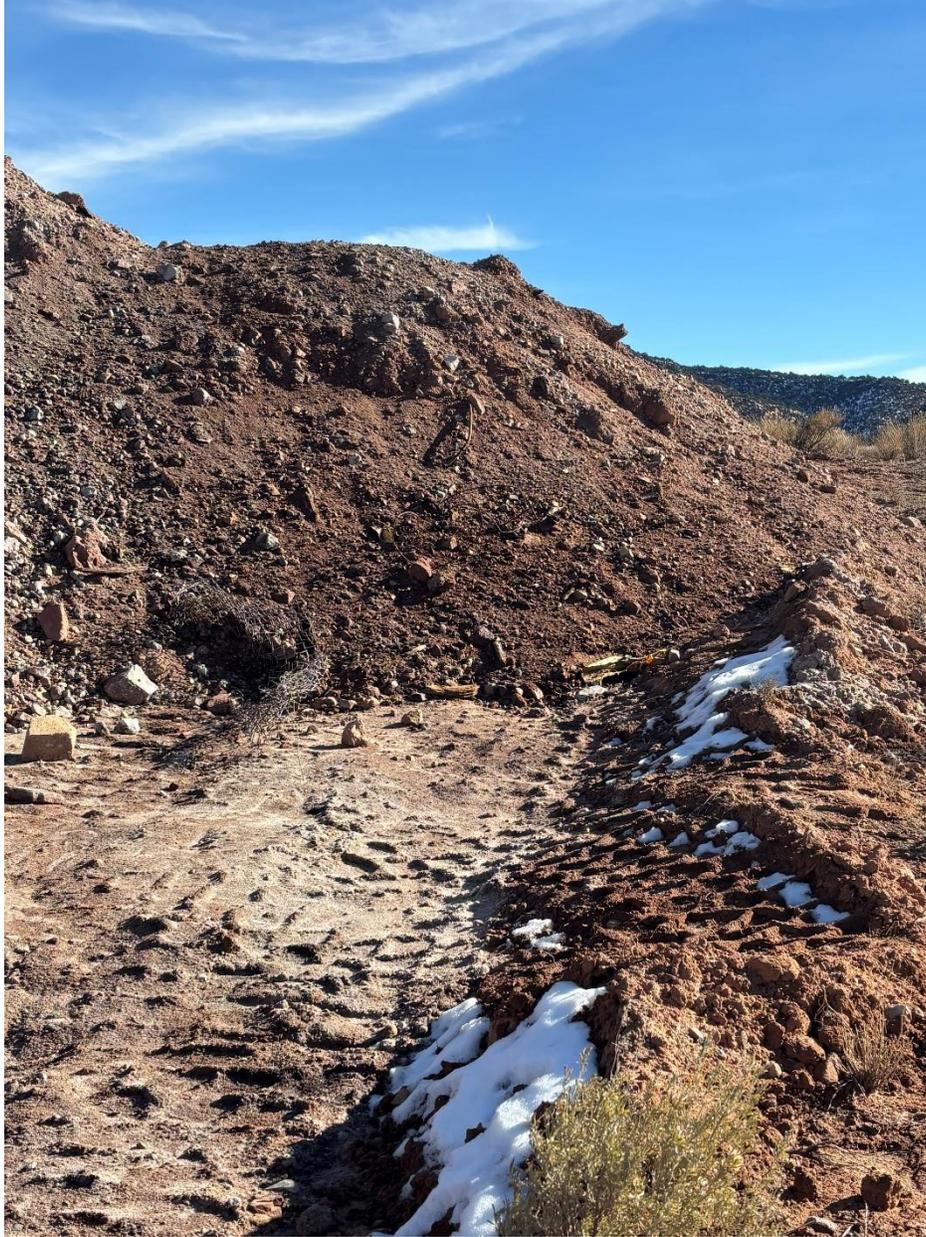
Latitude: , Longitude:
More trash.
