Aviation Investigation Final Report

Location:	Shaktoolik, Alaska	Accident Number:	ANC23FA042
Date & Time:	June 16, 2023, 11:35 Local	Registration:	N91361
Aircraft:	Cessna 180	Aircraft Damage:	Substantial
Defining Event:	Collision during takeoff/land	Injuries:	2 Fatal
Flight Conducted Under:	Part 135: Air taxi & commuter - Non-scheduled

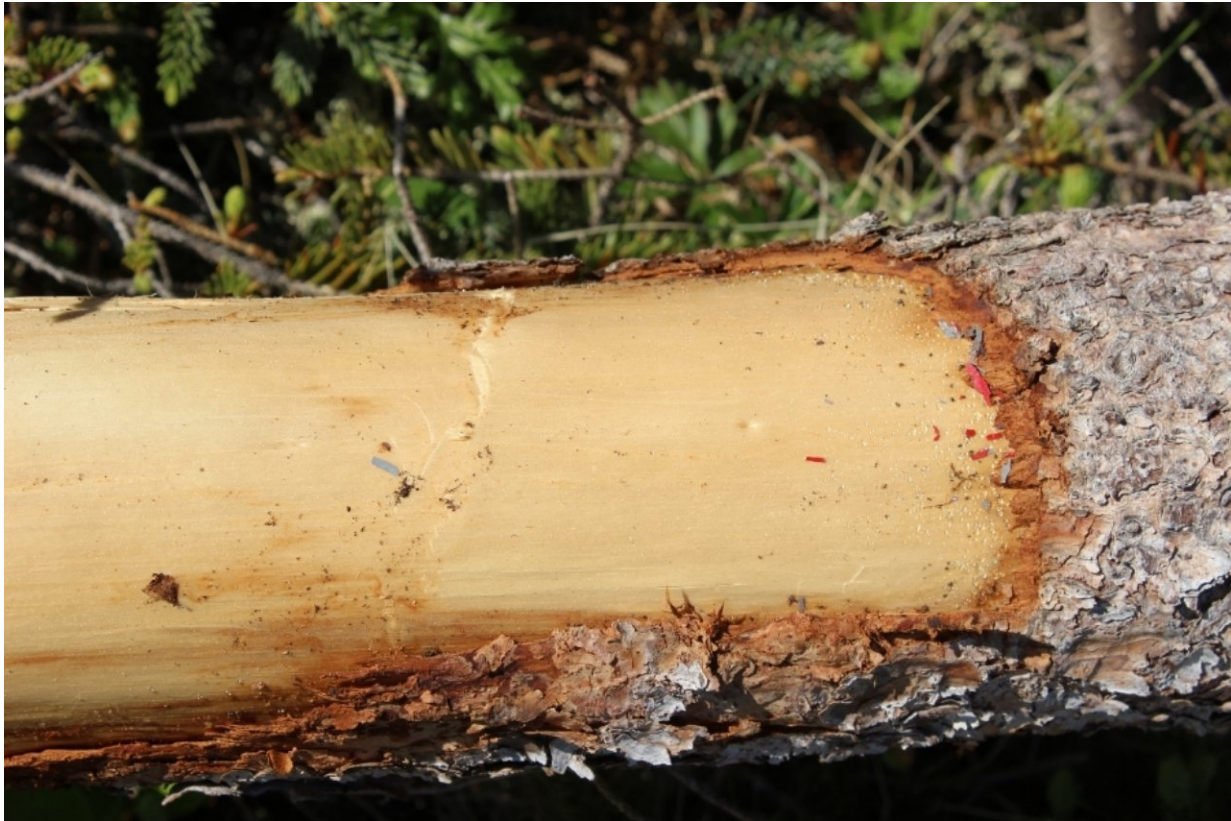
A small cluster of trees was present about 2/3 of the way down the left side of the 750-ft-long airstrip. One tree was fractured and displayed fragments of red paint that matched the accident airplane's paint color. The left horizontal stabilizer displayed a concave dent perpendicular to the leading edge about 1 ft outboard of the stabilizer root. Tree sap and embedded tree fibers were observed in the leading edge of the horizontal stabilizer.

Examination of the airstrip revealed a small cluster of trees about 2/3 of the distance from the beginning of the airstrip, on the left side and downslope. One 12-ft tree, about 4 inches in diameter, was fractured about 4 ft from its base. The separated portion of the tree was found next to its trunk and displayed fragments of red paint that matched the accident airplane's paint color.

Figure 1. View of the fractured tree with fragments of red paint.

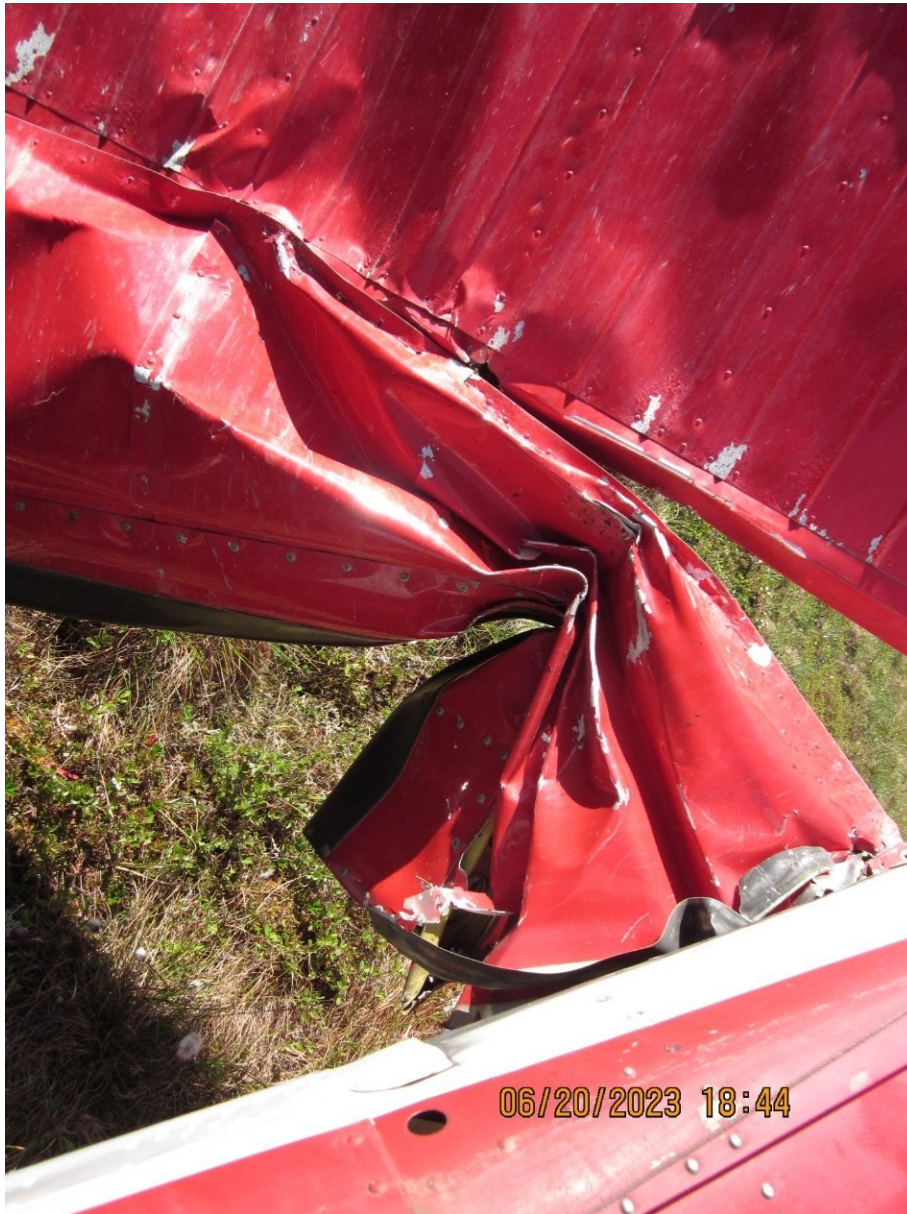
The left horizontal stabilizer displayed a concave dent perpendicular to the leading edge about 1 ft outboard of the stabilizer root. Tree sap and embedded tree fibers were observed in the leading edge of the horizontal stabilizer. The right horizontal stabilizer and elevator did not exhibit leading edge impact signatures, and the elevator remained attached.

Figure 2. View of the aft crushing on the horizontal stabilizer.
