Aviation Investigation Final Report

Location:	St. Mary's, Alaska	Accident Number:	ANC23FA074
Date & Time:	September 12, 2023, 20:47 Local	Registration:	N109T
Aircraft:	Piper PA-18-150	Aircraft Damage:	Substantial
Defining Event:	Loss of control in flight	Injuries:	1 Fatal
Flight Conducted Under:	Part 135: Air taxi & commuter - Non-scheduled

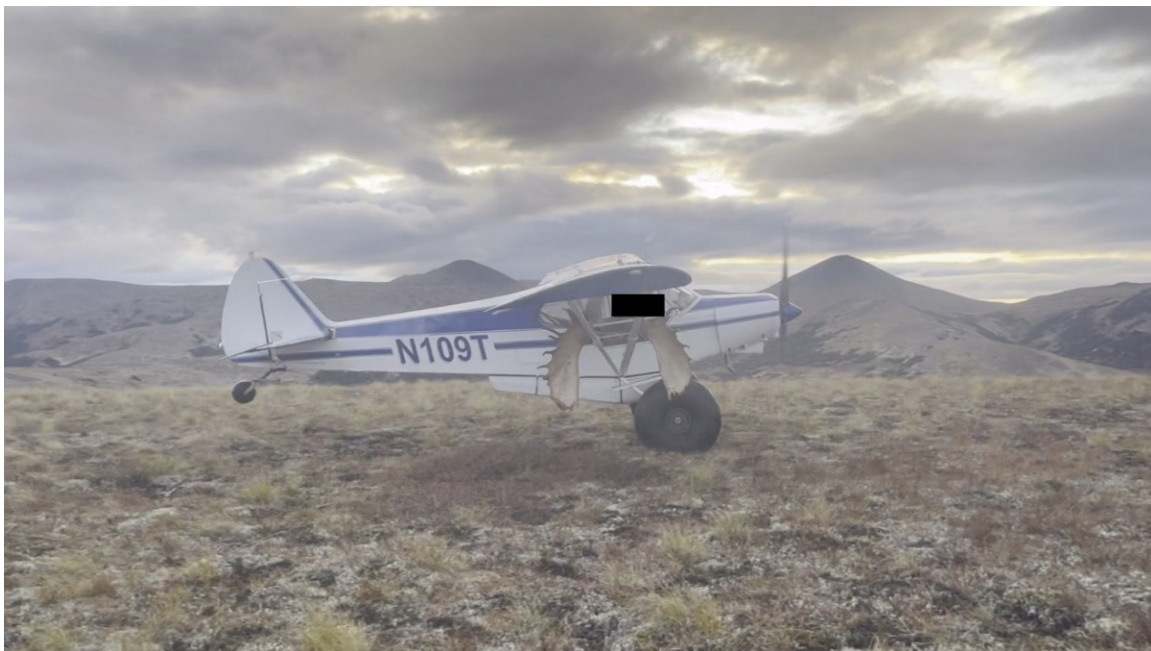
One of the hunters recorded a video of the takeoff. The video showed that the airplane began the ground roll at the southern end of the airstrip and departed uphill to the north. The flaps were retracted, and the tail of the airplane came up as soon as the pilot applied engine power (see figure 1). The ground roll lasted about 530 ft, and immediately after takeoff, the airplane pitched up and rolled right (see figure 2). The airplane then rolled to a wings-level attitude, and the video ended a few seconds later. The engine was heard operating during the recording and the airplane was not trailing smoke or vapor.

Figure 1. Airplane during the takeoff roll (Source: hunter video).

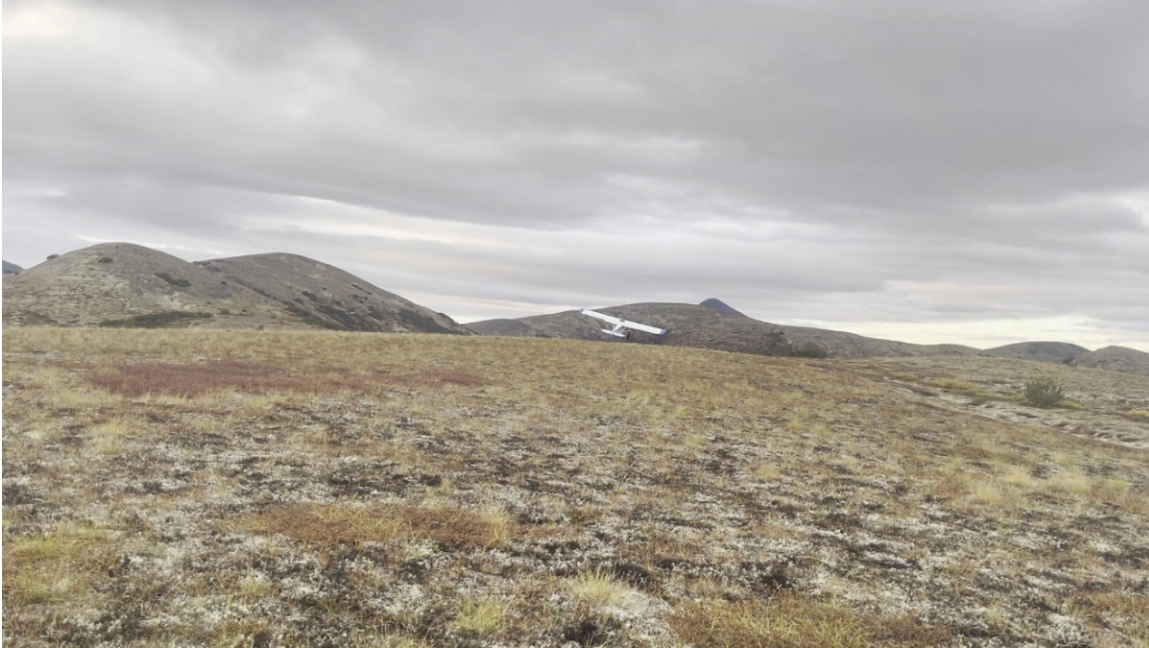
Examination of the cargo at the accident site indicated that it was still secured within the airframe, but was not secured within the cargo pod. Review of the takeoff video indicated that the airplane did not pitch up aggressively enough during the takeoff to have caused the unsecured meat in the cargo pod to shift. The antlers were still secured to the right wing strut and did not impede any of the flight control cables.

Figure 2 - Airplane rolling right immediately after takeoff (Source: hunter video).

Analysis revealed that the estimated pitch angle during takeoff was about 16.2°, and the right bank angle after rotation was 16.6°. The bottom of the cargo pod that was mounted under the fuselage sloped up by 13° toward the tail of the airplane when the airplane pitch angle was zero. Therefore, at the highest airplane pitch angle, the bottom of the cargo pod sloped down toward the tail by 3.2°, with an uncertainty of $\pm 1.5^\circ$.
