# Light Rail Collision Investigation Phoenix, Arizona

April 2010

CITY OF PHOENIX AND VALLEY METRO RAIL, INC.

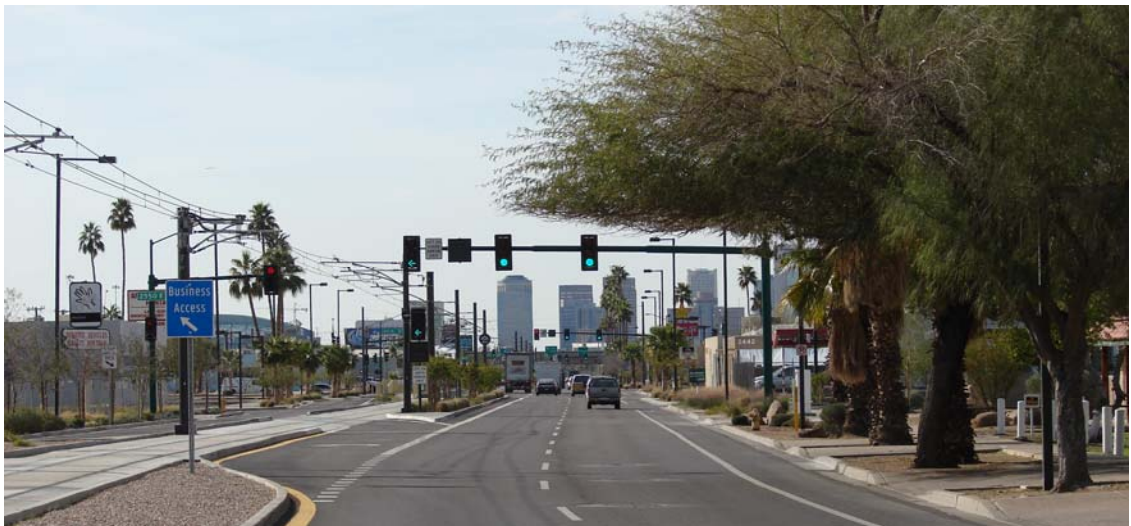
**Figure 1: 2550 East Washington Street – Westbound Approach – Distant**

The Entire Light Rail Transit route – both mainline and frontage roads – within the city limits of Phoenix was driven specifically to examine locations where vegetation was potentially obstructing traffic control devices from driver view. There was only one mainline location where vegetation potentially obstructed driver view of traffic control devices for the Light Rail Transit system. This location was westbound Washington Street approaching the traffic signal at 2550 East Washington. As indicated in **Figure 1** and **Figure 2** the traffic control devices are visible beyond the tree. Recognizing that this location was the only location where vegetation potentially obstructed driver view of Light Rail Transit traffic control, there are no locations where vegetation should be trimmed or removed to provide visibility.

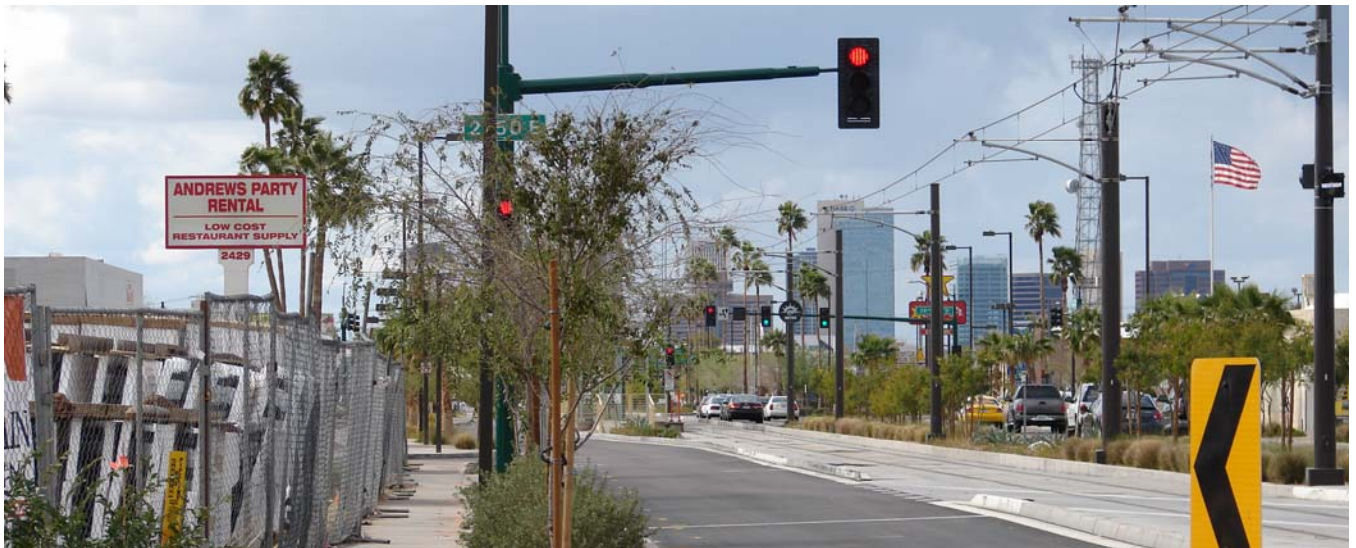
**Figure 3: 2550 East Washington Street – Left-side Frontage Road Approach**

There were several frontage road locations where the side-mounted pole signal heads were obstructed by vegetation – as indicated in the representative photographs of **Figure 3** through **Figure 6**. All photographs were taken from the travel lane in the approximate location of a driver eye. In each of the circumstances throughout the Light Rail system within Phoenix, the overhead mast arm signal head was clearly visible several hundred feet prior to the signal. Also, at each location, the side-mounted pole signal head was clearly visible from a vehicle at the stop bar.

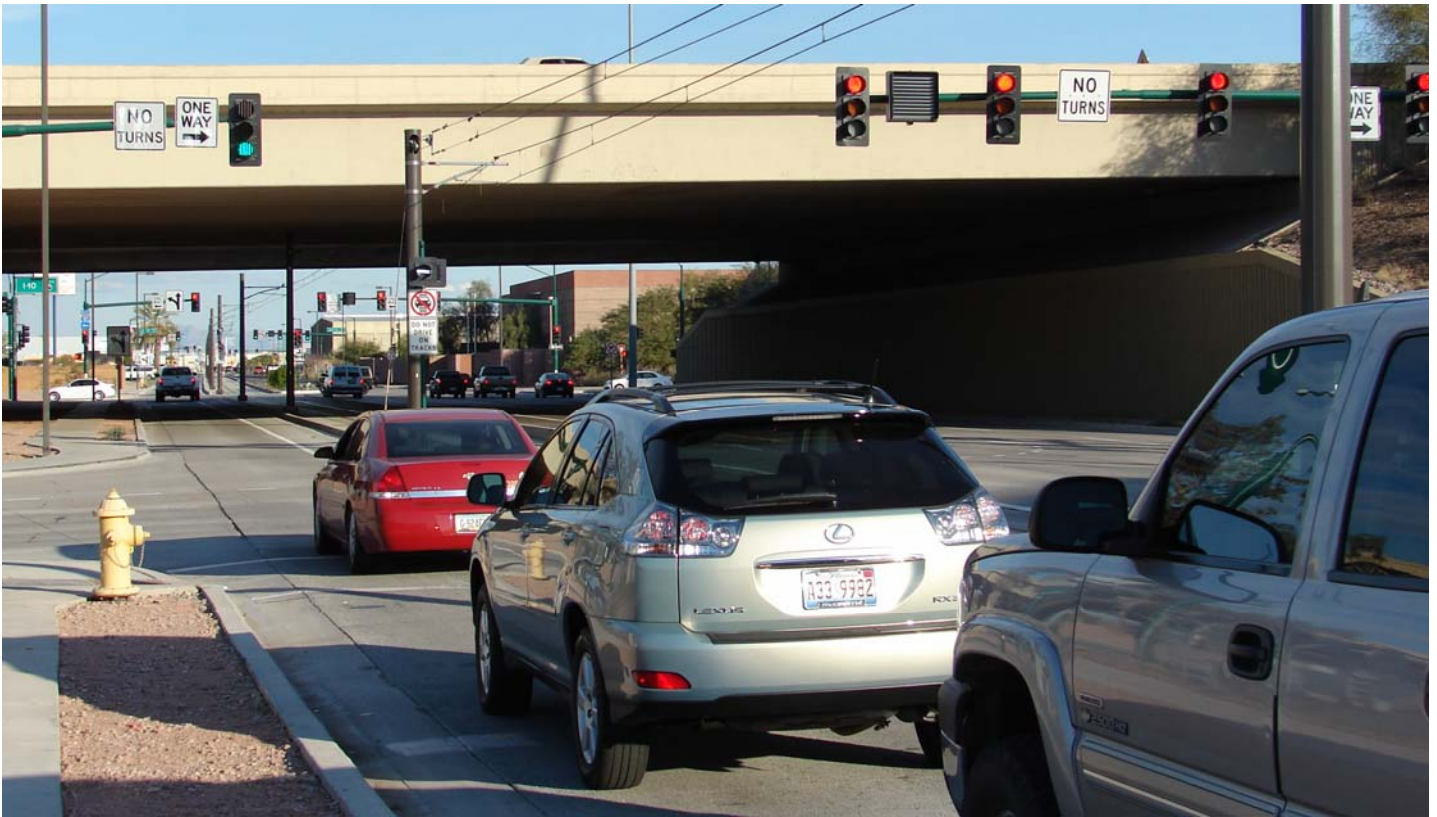
**Figure 7: I-10 / Jefferson West Signal – LRT Stop, Mainline Red, Frontage Green**

A specific investigation at the I-10 / Jefferson / Washington interchange recommended that the traffic signal timing be changed to provide motor vehicle right-of-way when Light Rail Vehicles were not approaching. This signal timing was implemented in November 2009. The modified traffic signal timing permits traffic from the mainline to cross-over the Light Rail Transit tracks to the frontage road. The Light Rail Vehicle receives a stop indication during the green indication for this motor vehicle movement. It required video detection for the frontage roads, and no-turn-on-red signs for northbound and southbound traffic.

**Figure 7** through **Figure 11** provide a sequence of photographs of the signal operation. This signal operation has been frequently observed since its implementation, and has increased both safety and efficiency.

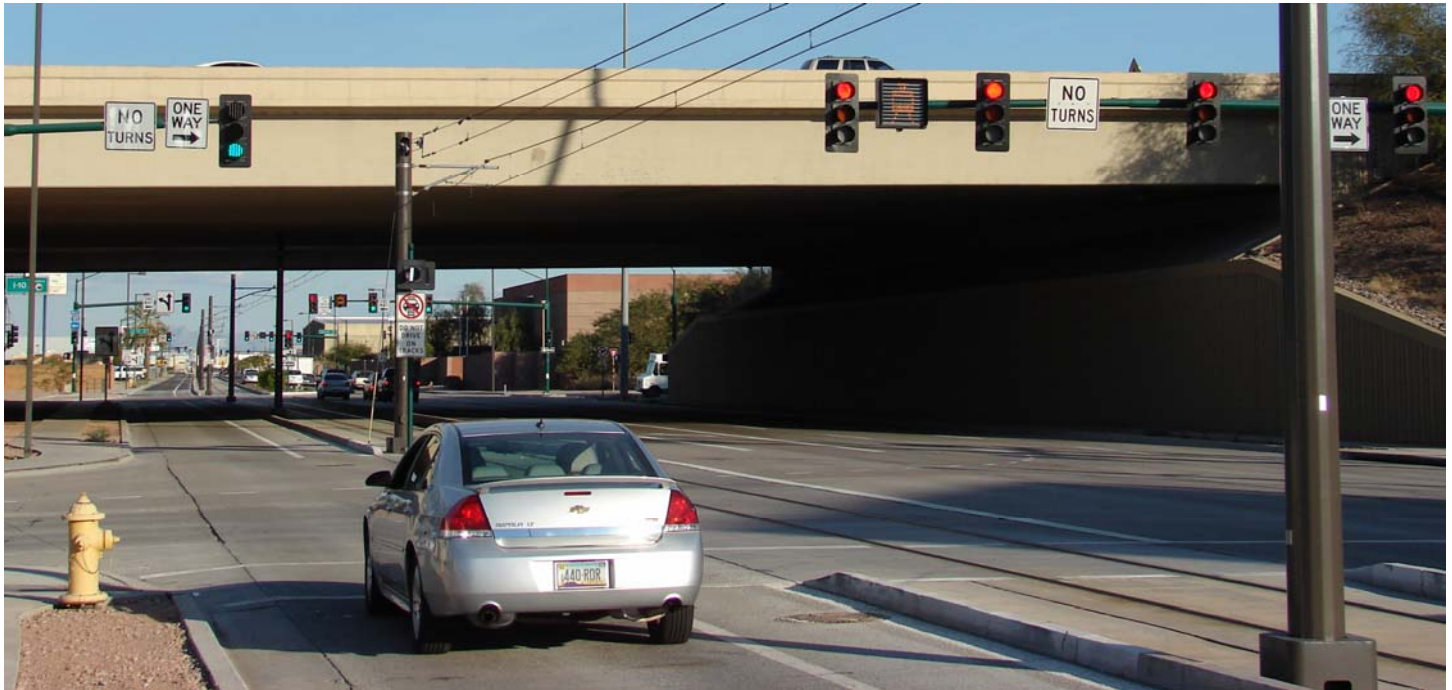
**Figure 8: I-10 / Jefferson West Signal – LRT Go, Mainline Red, Frontage Green**

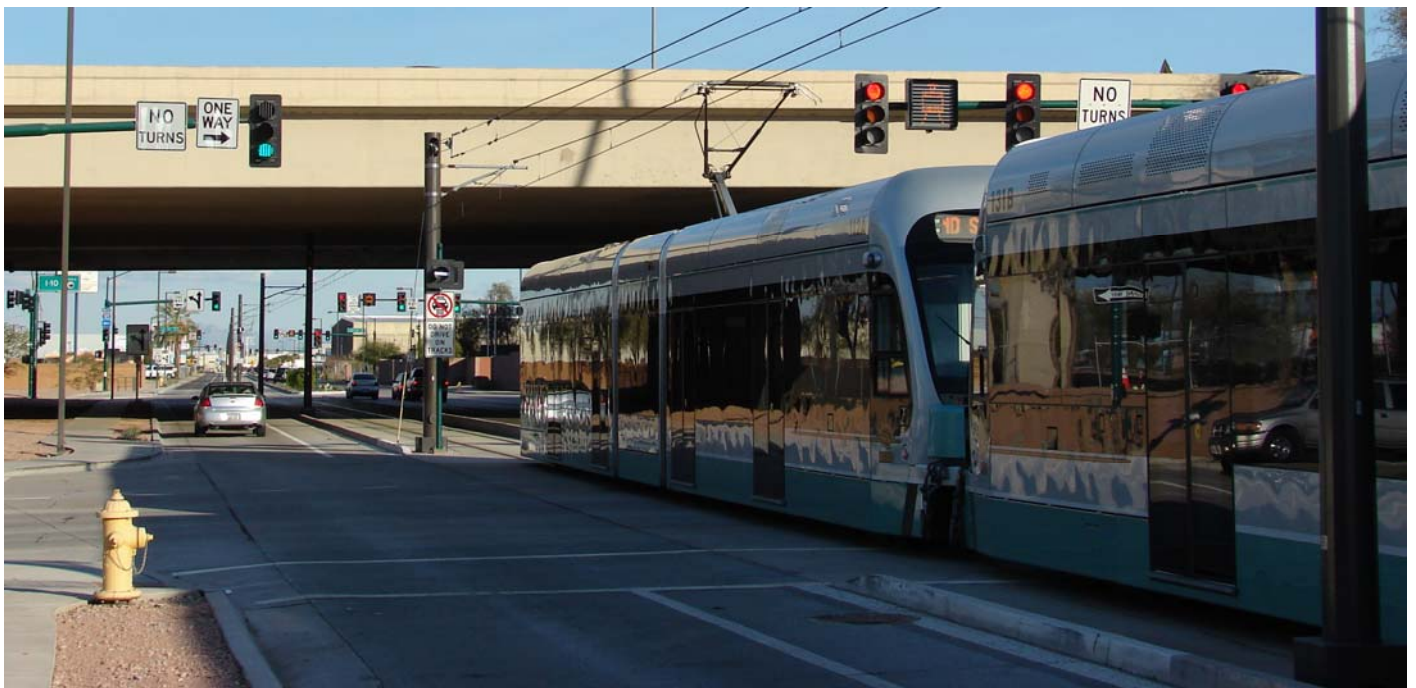
**Figure 9: I-10 / Jefferson West Signal – LRT Go, Mainline Red, Frontage Green (with LRV)**

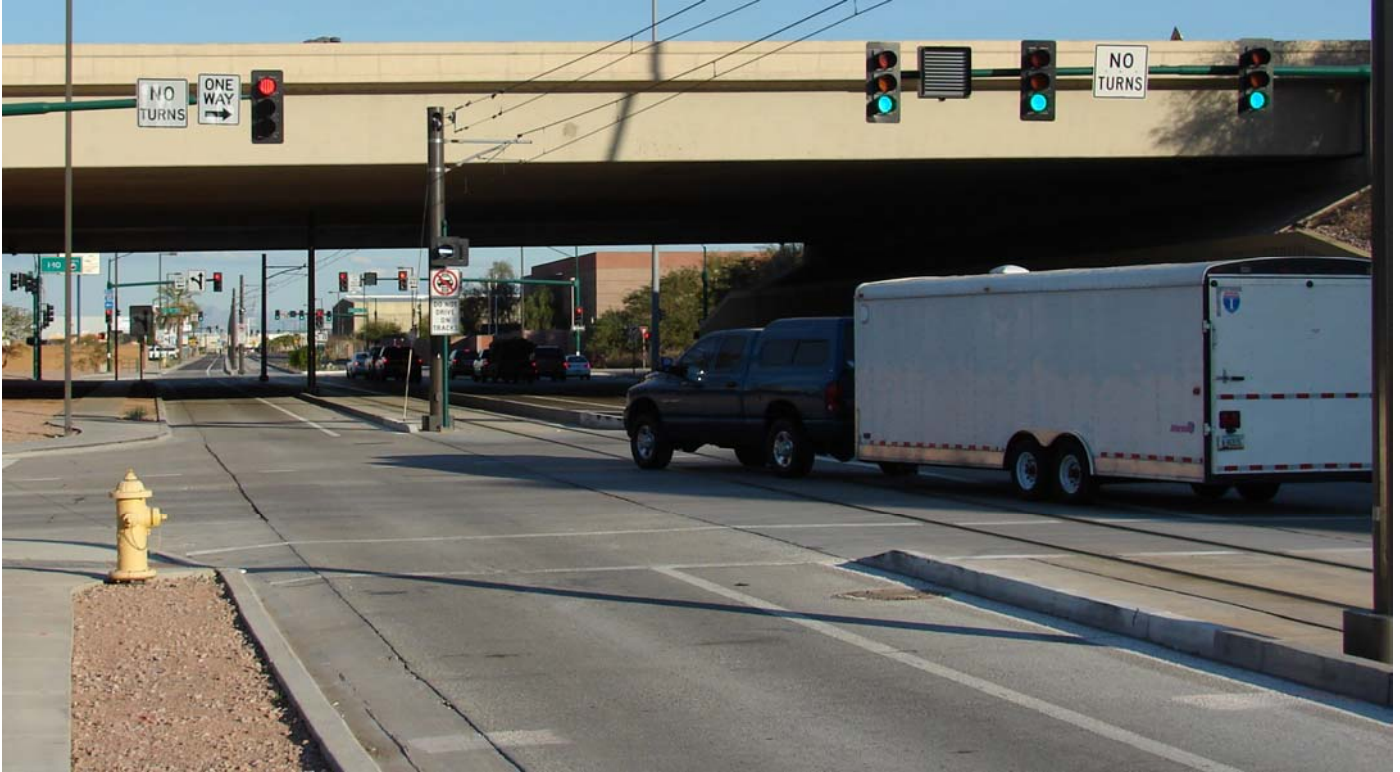
Figure 10: I-10 / Jefferson West Signal – LRT Stop, Mainline Green, Frontage Red (Truck 1)

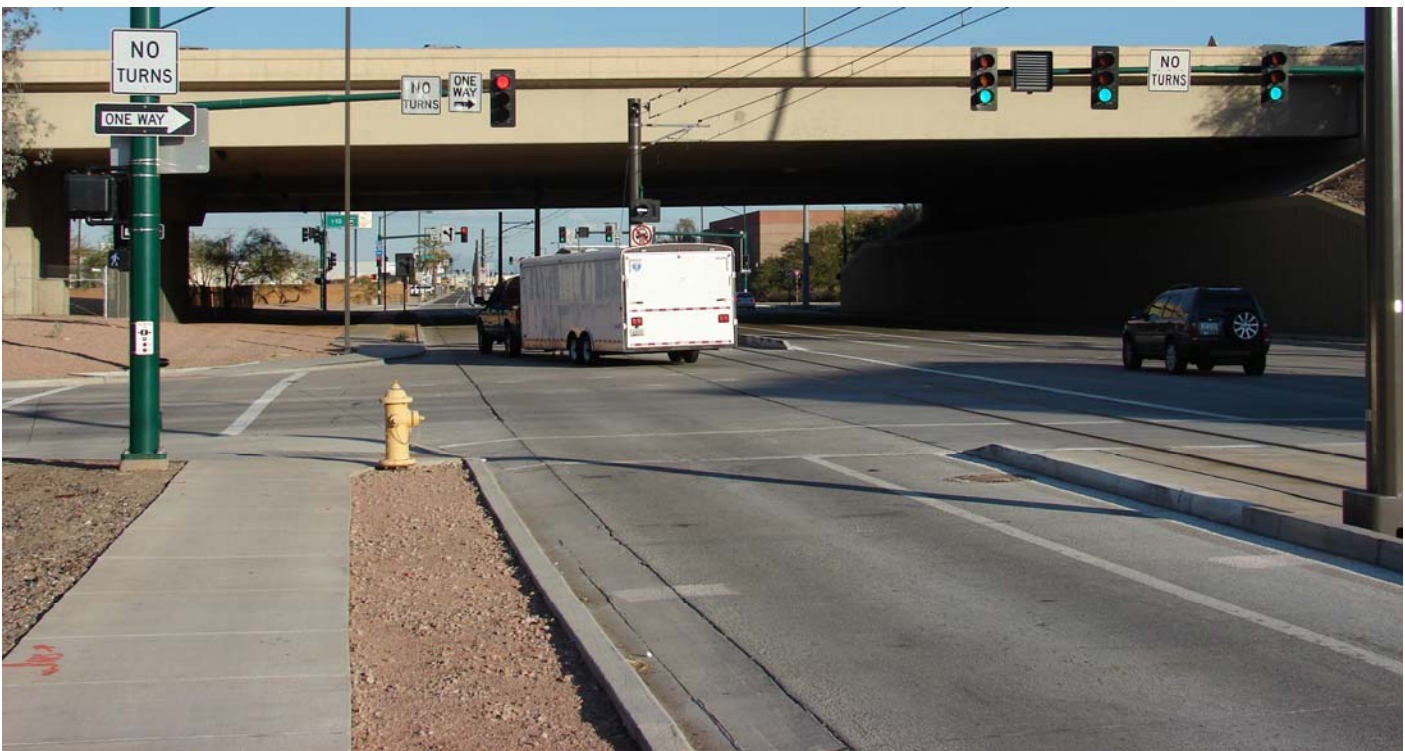
Figure 11: I-10 / Jefferson West Signal – LRT Stop, Mainline Green, Frontage Red (Truck 2)

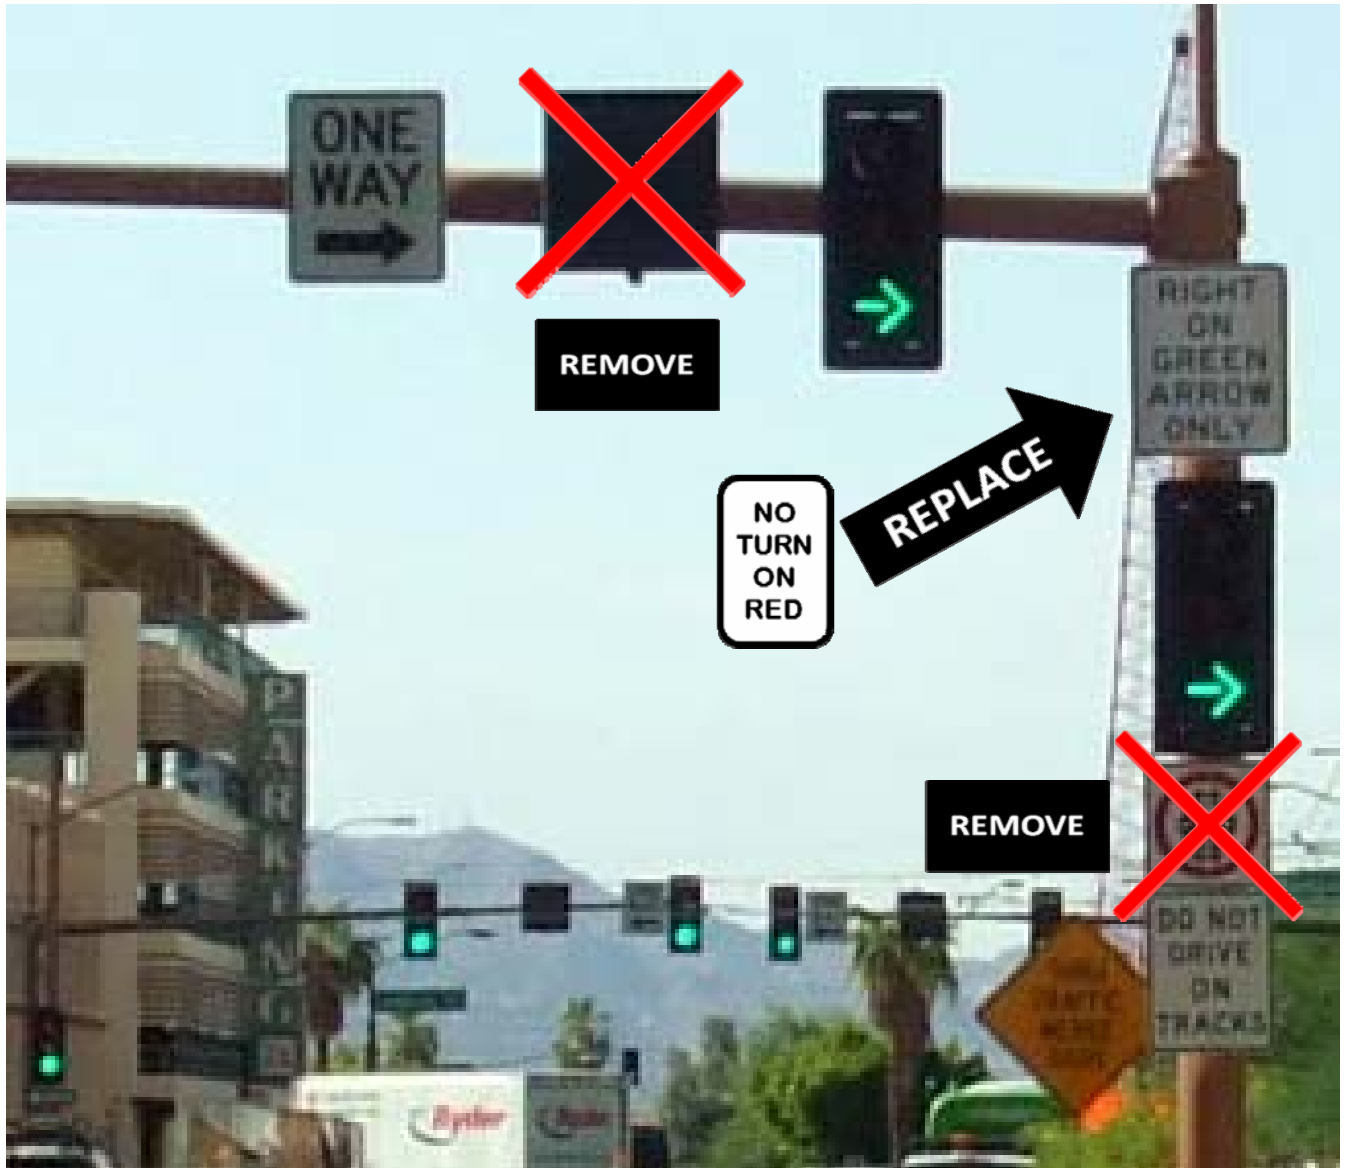
Figure 12: Recommendations

8. The blank-out signs for motor vehicle traffic parallel to the Light Rail Transit tracks should be removed. For system maintenance purposes, another device would be necessary to inform signal and system personnel of approaching Light Rail Vehicles. The blank-out signs on driveways perpendicular to the Light Rail Transit tracks that access frontage roads near track crossover locations should remain.
9. The signal timing for all intersections with one-way Light Rail Transit operation should be modified to be similar to the recently implemented operation at I-10 / Jefferson / Washington, particularly at locations with red turn arrows.

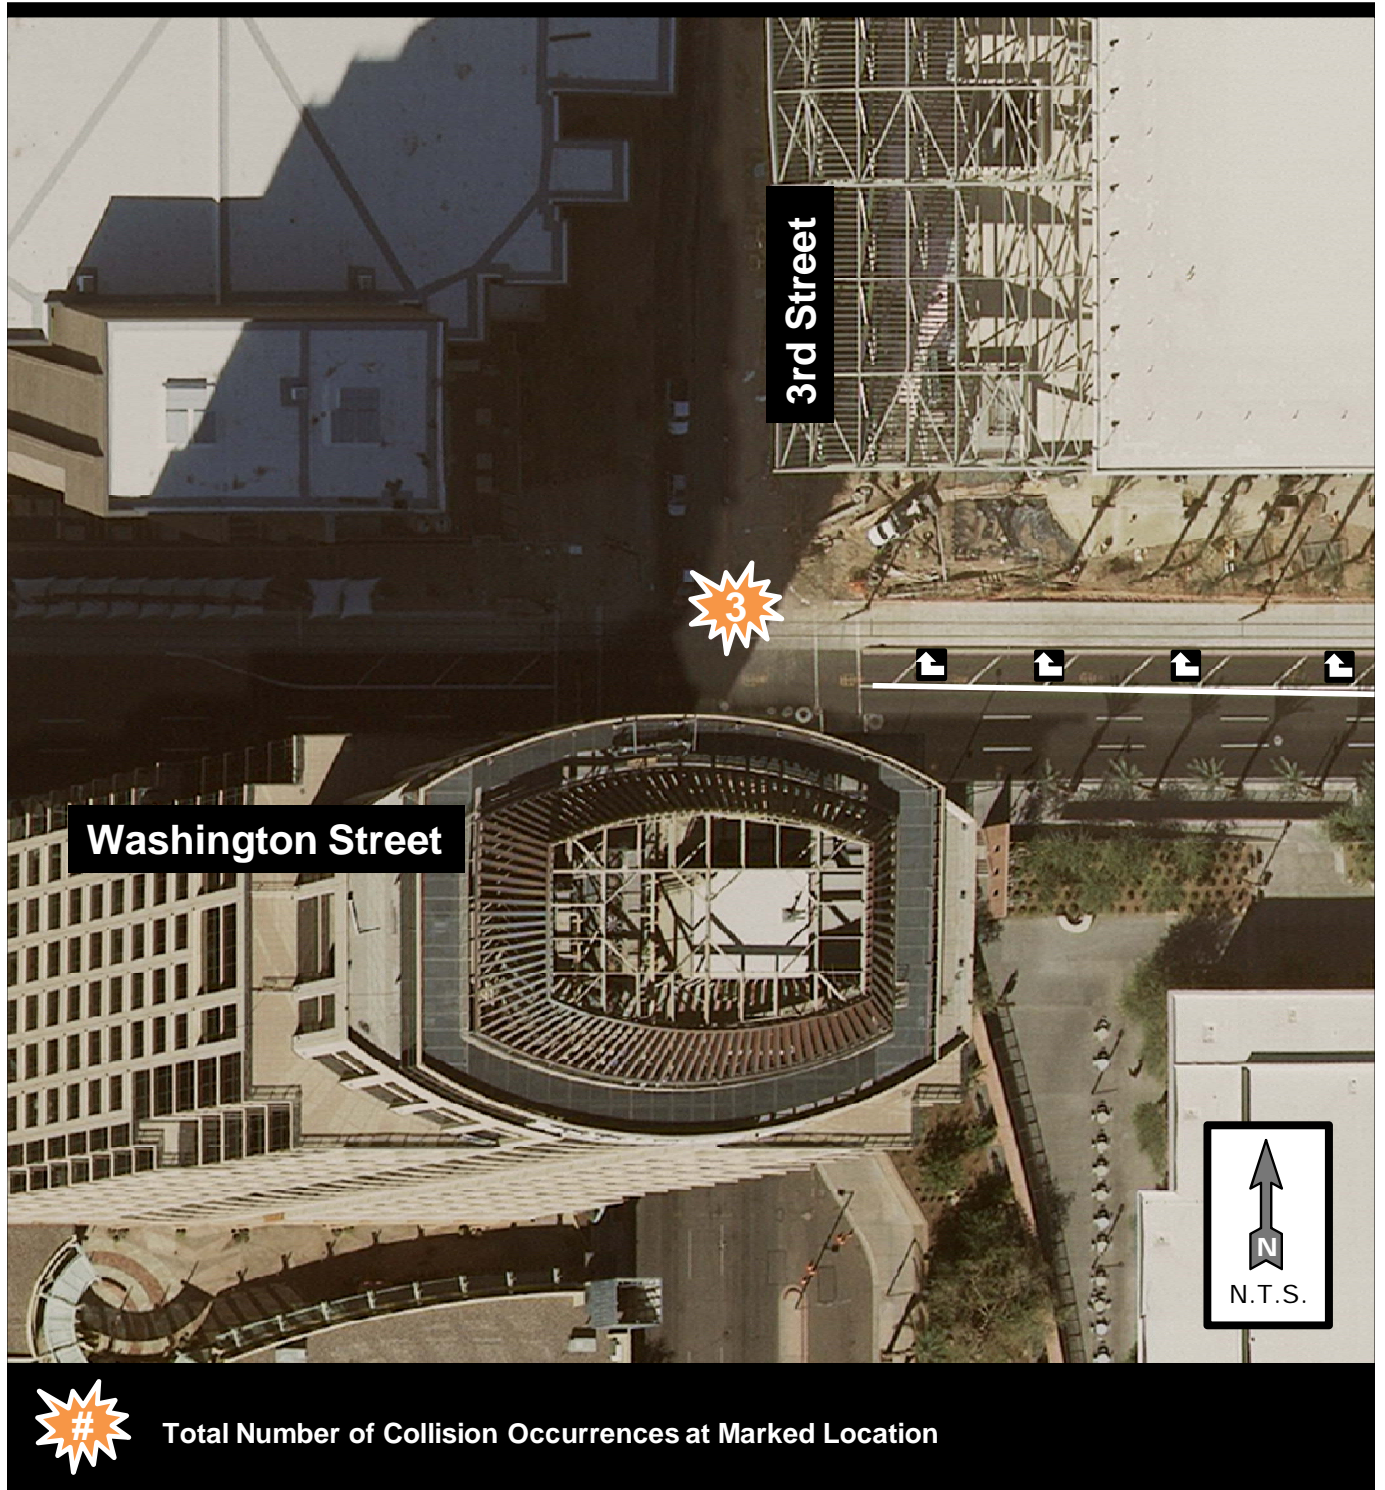
Report #	Date	Movement	Vehicle	LRT	Sun Location	Violation
961-090047737	1/9/2009	Right-turn	WB	WB	Into Sun	Disregarded Signal
961-090219819	2/6/2009	Right-turn	WB	WB	Night	Failed to Stop
961-091122709	7/14/2009	Right-turn	WB	WB	Sun Behind	Disregarded Signal

Figure 22: 3<sup>rd</sup> Street and Washington Street – Collision Location

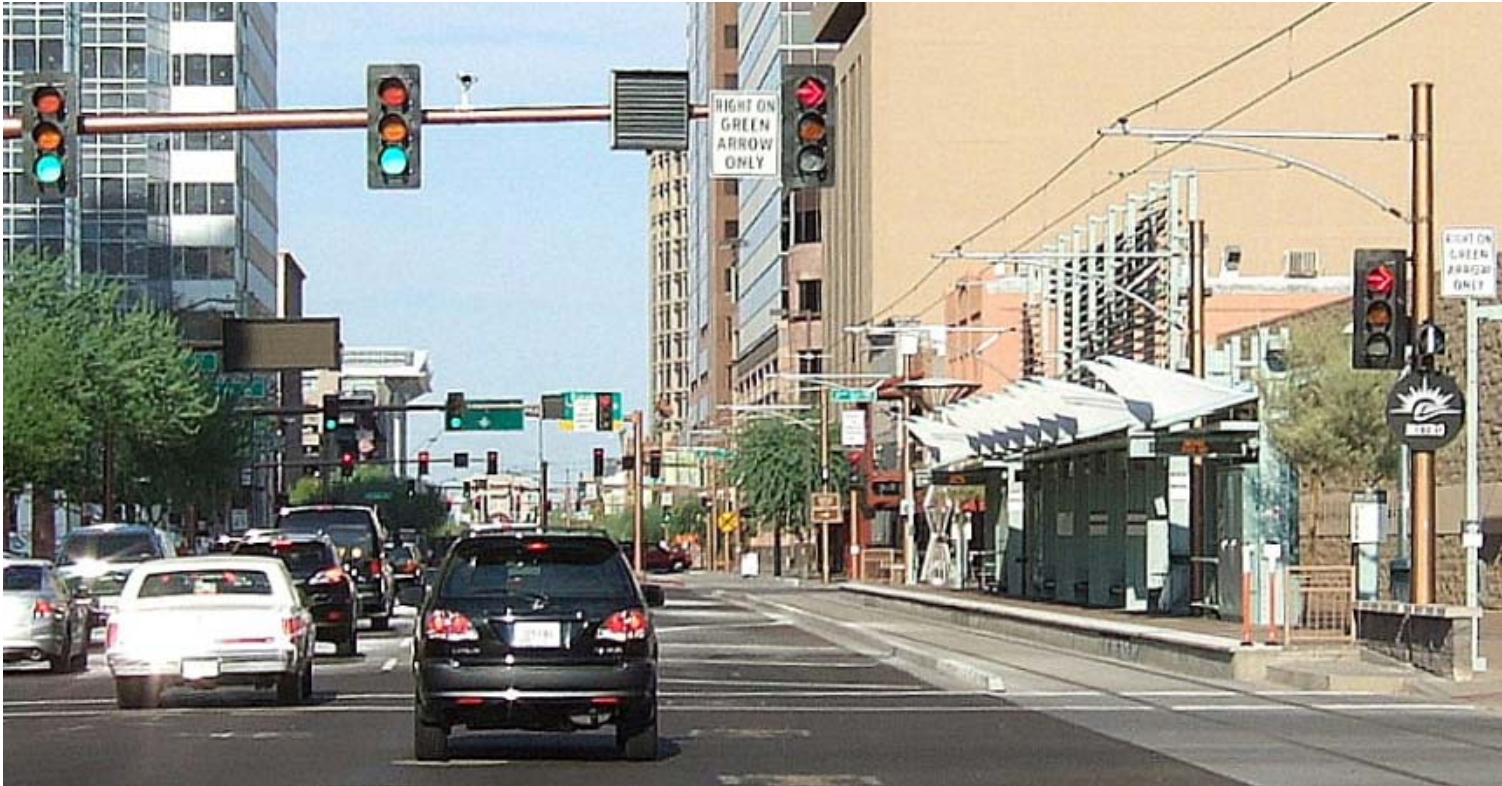
Figure 23: 3<sup>rd</sup> Street and Washington Street – Existing Traffic Control

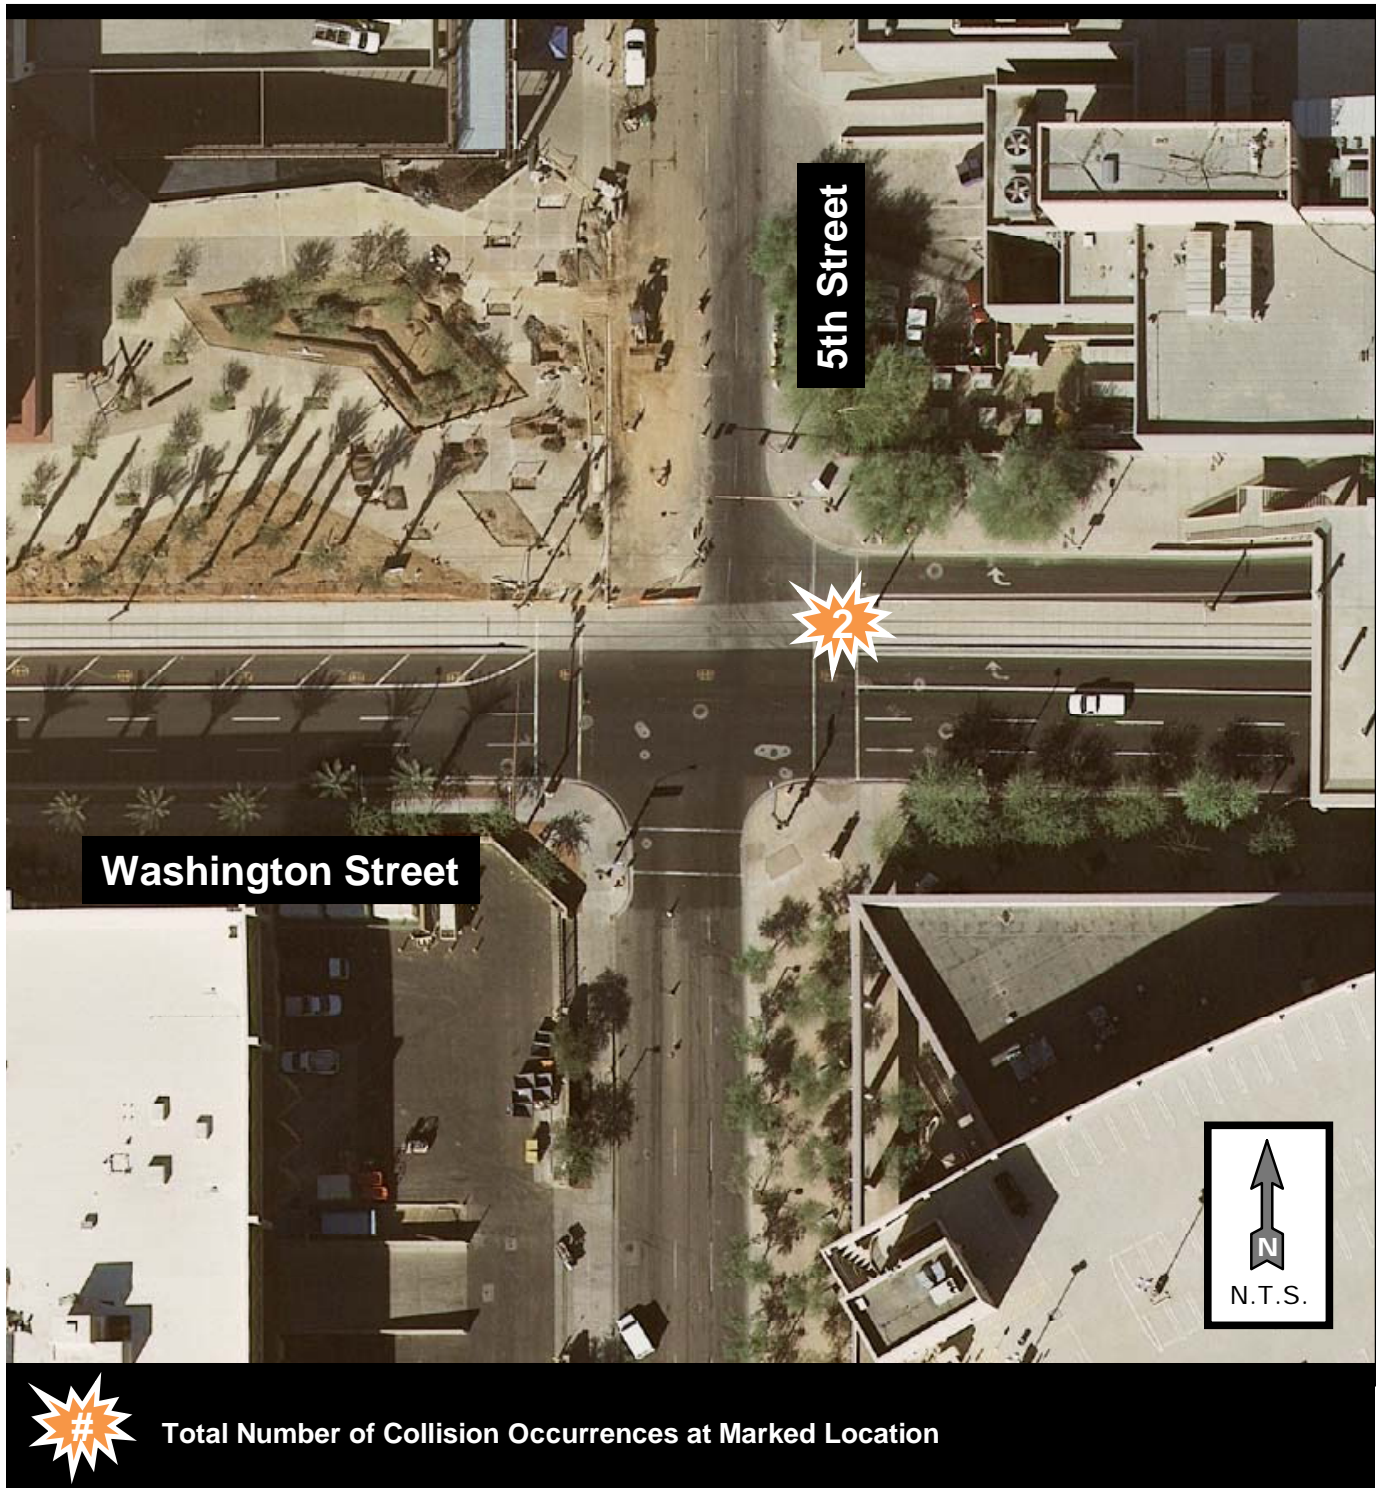
Report #	Date	Movement	Vehicle	LRT	Sun Location	Violation
961H-090600740	4/14/2009	Right-turn	WB	WB	No Influence	Disregarded Signal
961-090646579	4/22/2009	Right-turn	WB	WB	Sun Behind	Disregarded Signal

Figure 26: 5<sup>th</sup> Street and Washington Street – Collision Location

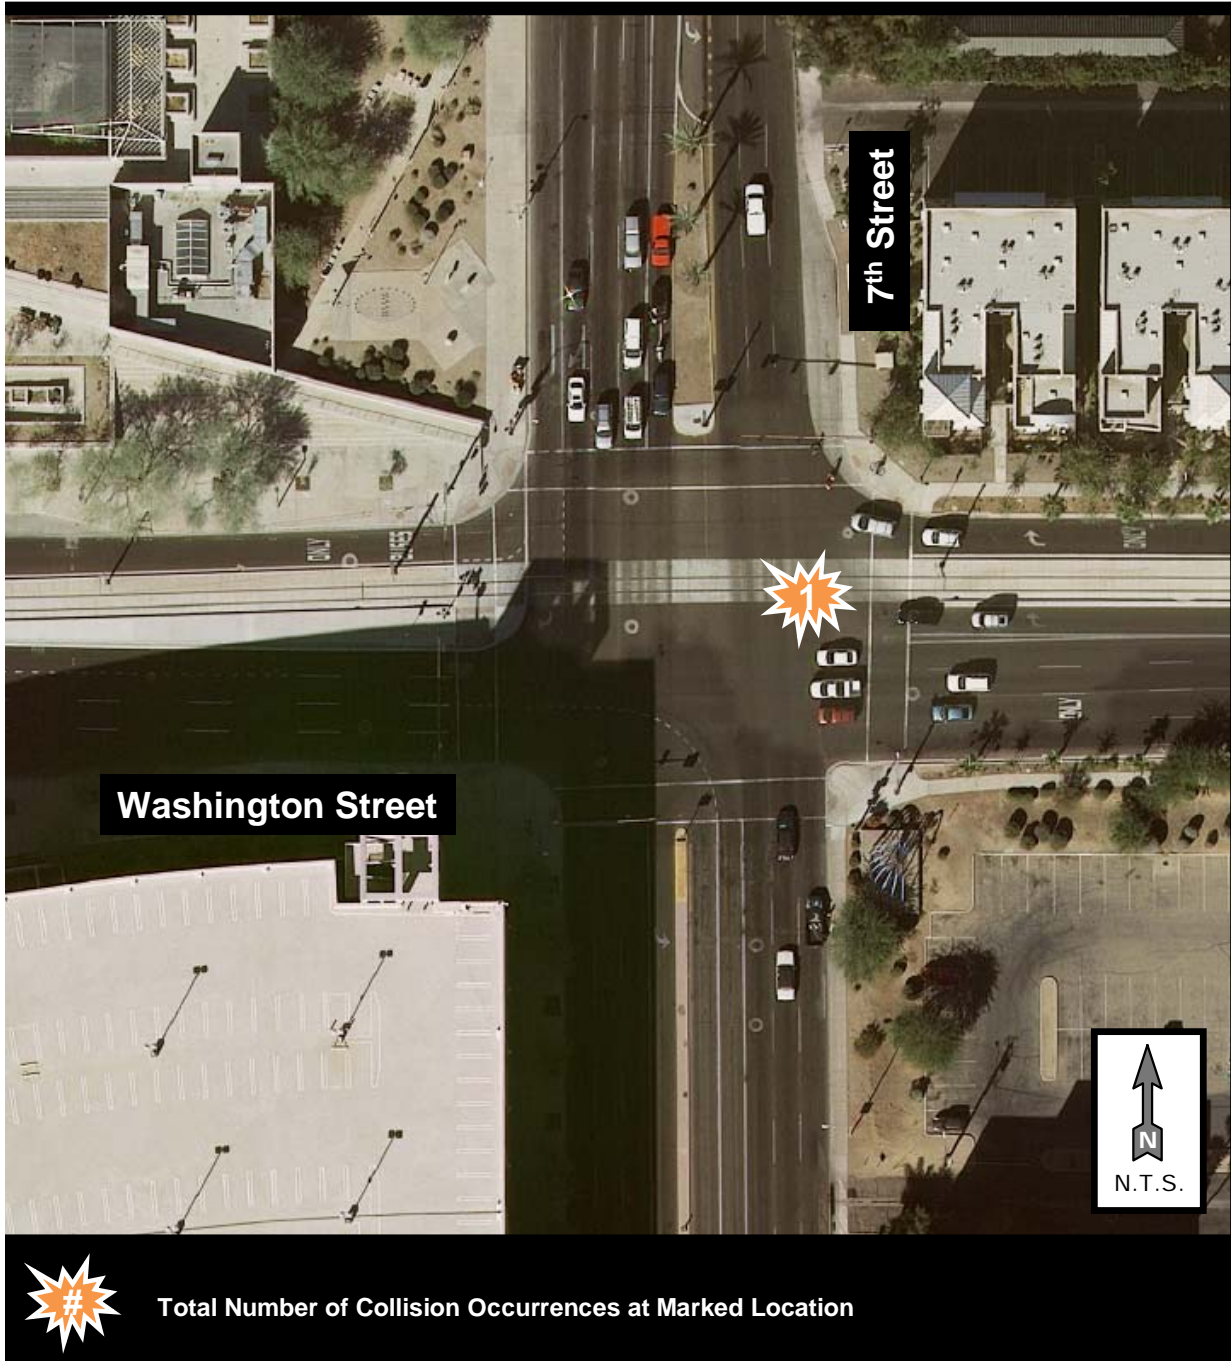
Report #	Date	Movement	Vehicle	LRT	Sun Location	Violation
961-091011167	6/24/2009	Right-turn	WB	WB	No Influence	Disregarded Signal

Figure 30: 7<sup>th</sup> Street and Washington Street – Collision Location

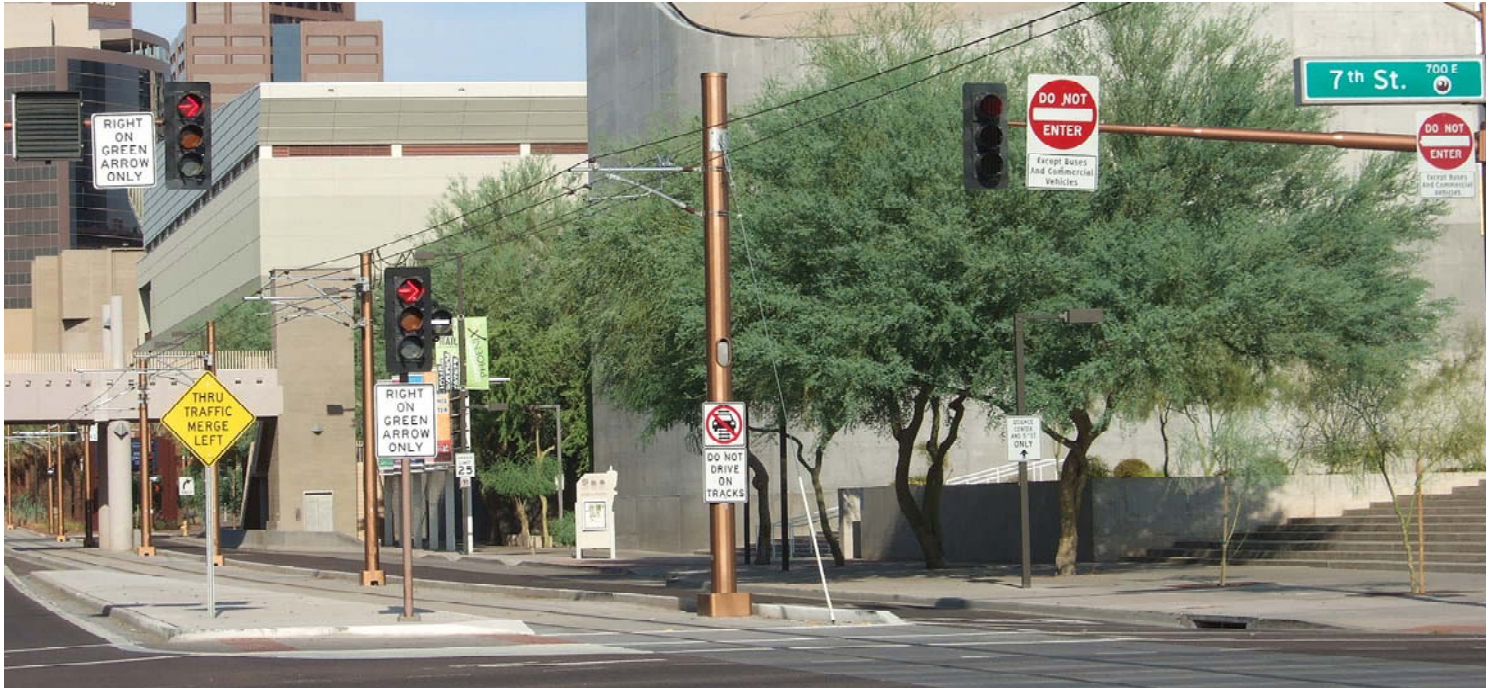
Figure 31: 7<sup>th</sup> Street and Washington Street – Existing Traffic Control

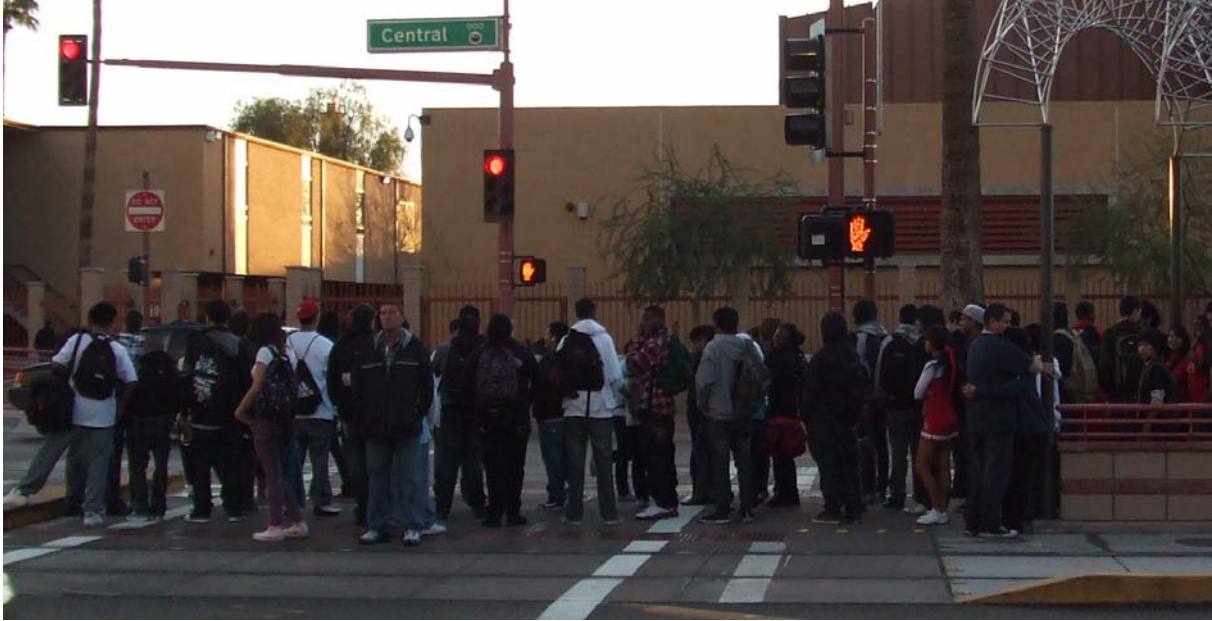
Figure 52: Central Avenue and Campbell Avenue – Pedestrian Demand on DON'T WALK

**INCREASE PEDESTRIAN WALK TIME  
DURING PEAK 20-MINUTE PERIODS OF  
SCHOOL ARRIVAL AND DEPARTURE**

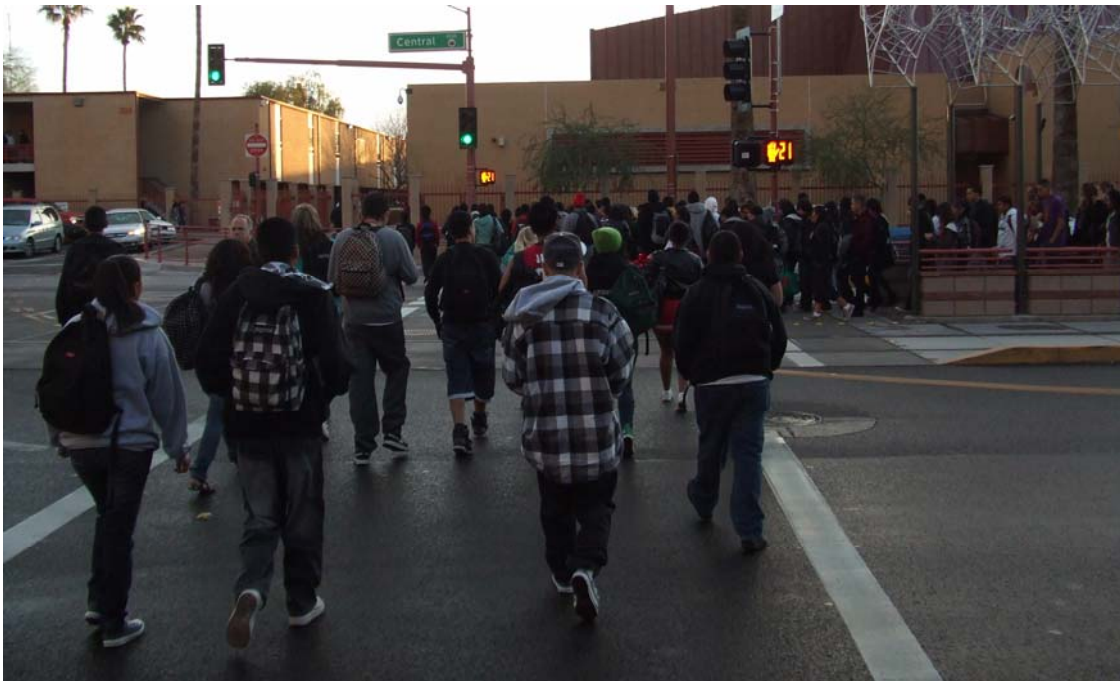
Figure 53: Central Avenue and Campbell Avenue – Pedestrian Demand on WALK

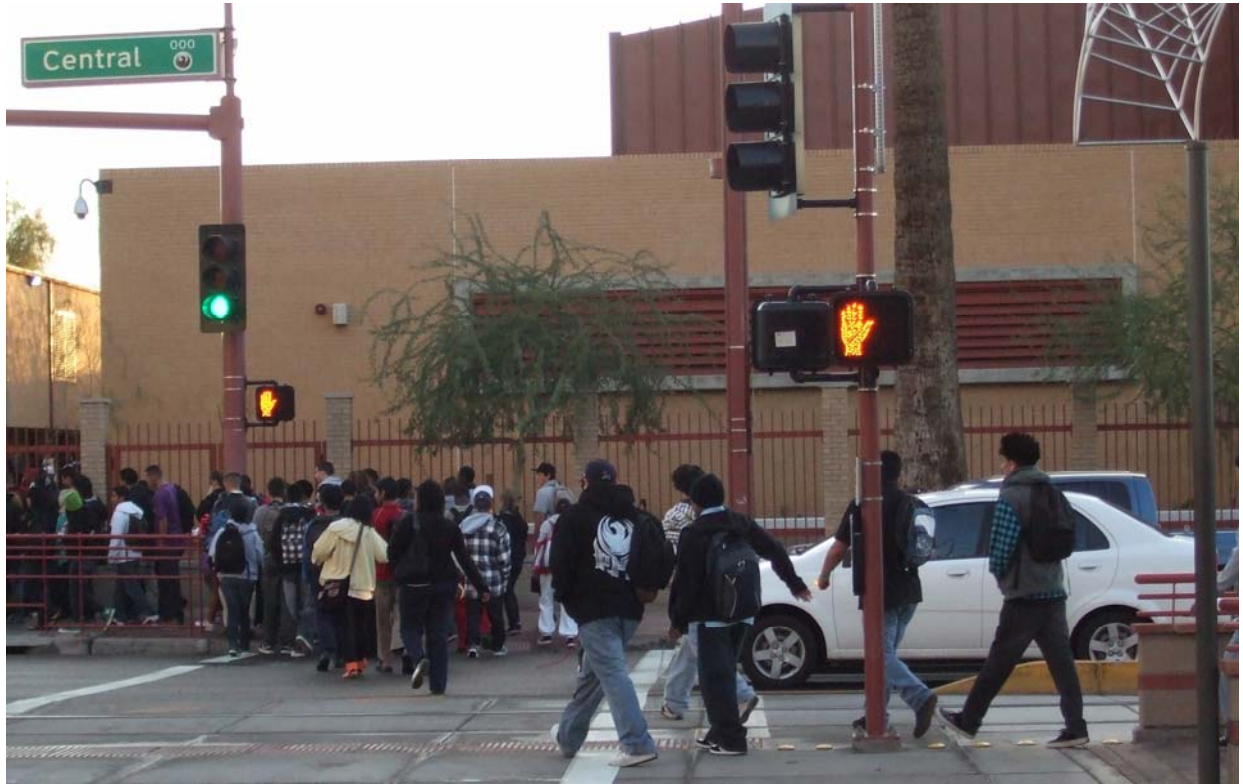
Figure 54: Central Avenue and Campbell Avenue – Pedestrian Demand on DON'T WALK

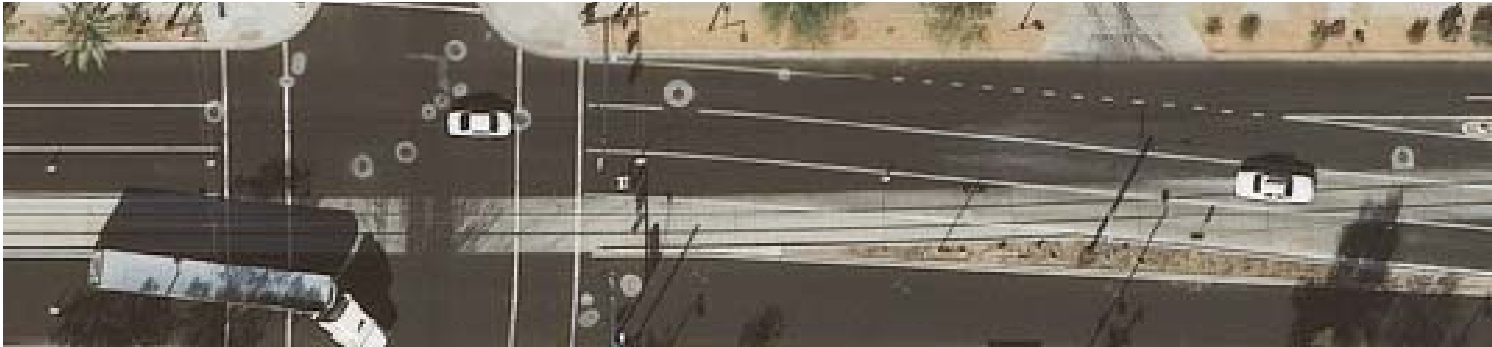
**Figure 91: Jefferson, East of 9<sup>th</sup> Street – Existing Traffic Control**

This recommendation requires one of two (2) modifications. At the crosswalk, east of 9<sup>th</sup> Street, the distance from the curb to the concrete track base is approximately 32 feet. The distance from the curb to the rail is approximately 36 feet. Reconstruction of the curb and sidewalk in the northeast corner of the intersection would provide additional width for the recommended bicycle lane. Alternatively, the crossover could begin at the crosswalk.

An alternative recommendation is to retain the bicycle lane on the north side of the frontage road, and transition the bicycle lane across the motor vehicle travel lanes further east – separated from the intersection with 9<sup>th</sup> Street.

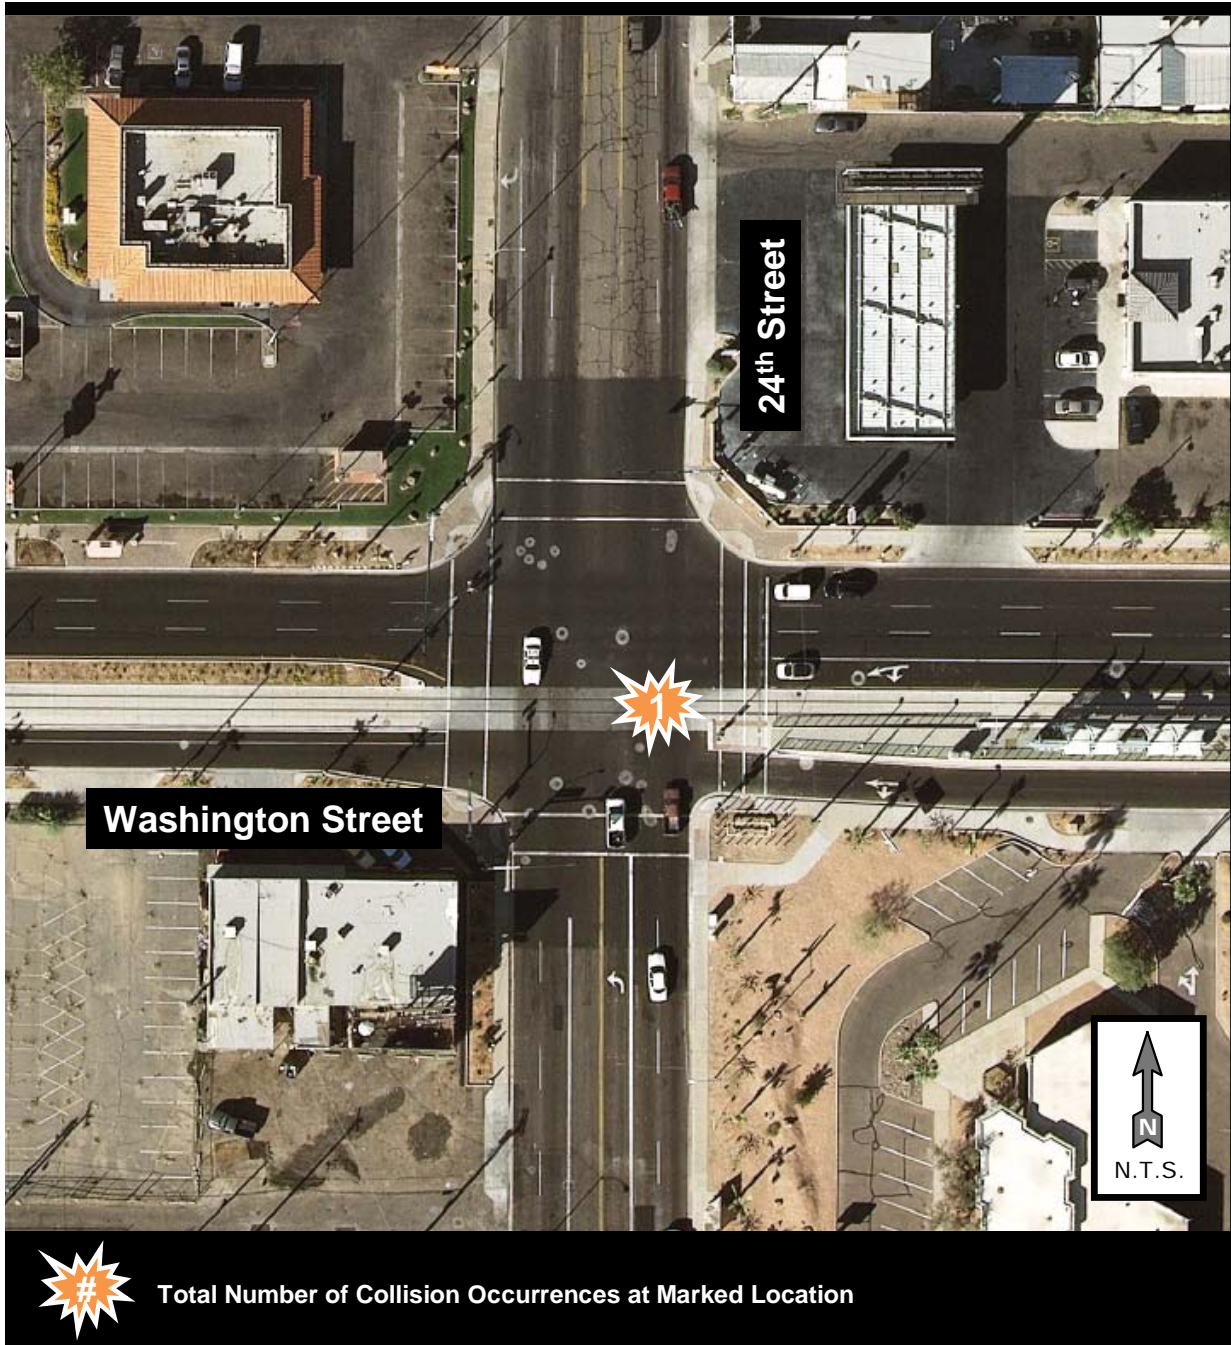
Report #	Date	Movement	Vehicle	LRT	Sun Location	Violation
961-082053060	12/2/2008	Through	NB	WB	No Influence	Disregarded Signal

Figure 98: 24<sup>th</sup> Street and Washington Street – Collision Location
