# Light Rail Collision Investigation Phoenix, Arizona

April 2010

CITY OF PHOENIX AND VALLEY METRO RAIL, INC.

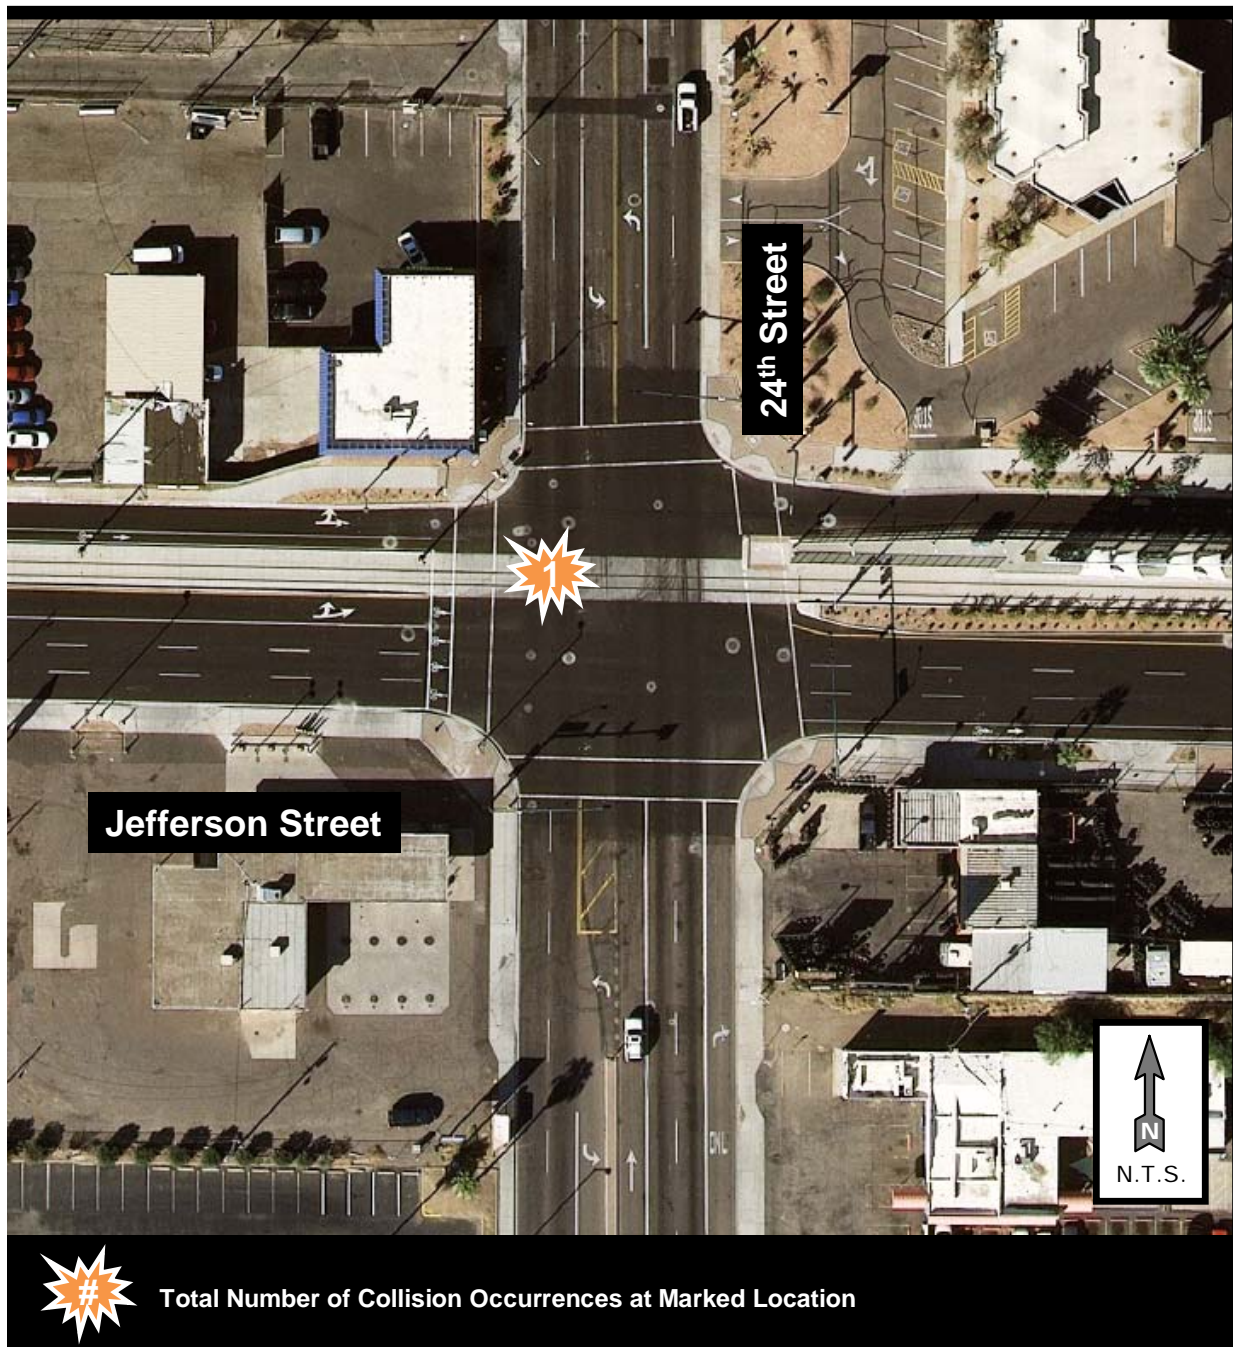
Report #	Date	Movement	Vehicle	LRT	Sun Location	Violation
961-091212116	7/30/2009	Through	SB	EB	No Influence	Disregarded Signal

Figure 101: 24<sup>th</sup> Street and Jefferson Street – Collision Location
